# Access Compliance Report

## Public Rights-of-Way

### (Curb Ramps)

| Intersection ID: 28614 | Main Street: KESTRAL_RIDGE_DR | Cross Street: WARBLER_WOOD_CT | Location: SE |

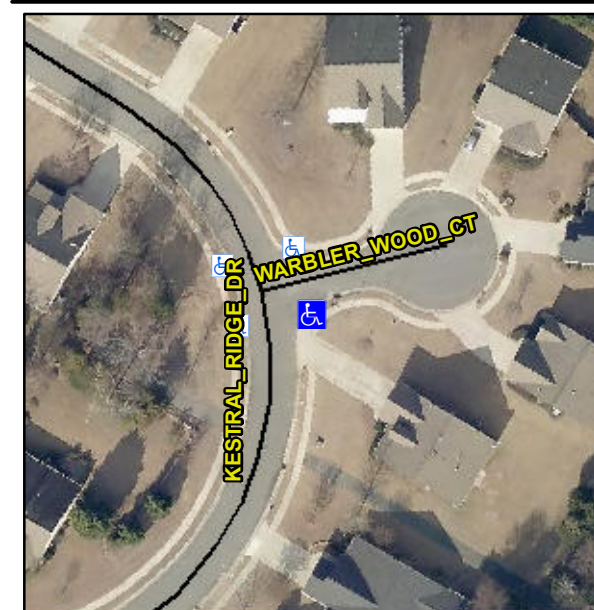
**Not Found, R304.2.1, R305.1.4, R302.7.2, R304.5.4**

| Compliance | Description | Data | Compliance | Description | Data |
|---|---|---|---|---|---|
| No | Landing Length (in) | 47.0 | Yes | DWS Provided? | Yes |
| Yes | Landing X Slope (%) | 1.7 | No | DWS Full Width? | No |
| Yes | Gutter Ponding? | No | No | Gutter Slope (%) | 10.8 |
| No | Gutter Lip Ht (in) | 1.0 | Yes | Gutter X Slope (%) | 0.1 |

**Remove & Replace Curb Ramp With Two New Directional Ramps or Equivalent. Remove & Replace Gutter.**

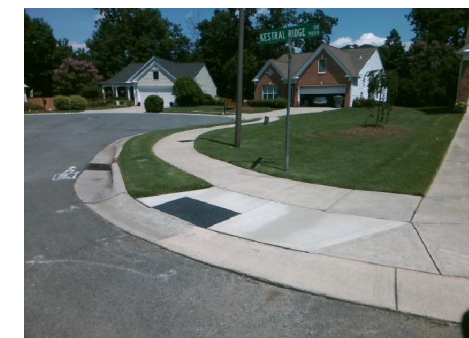
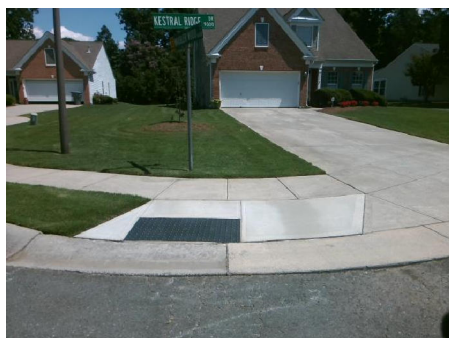
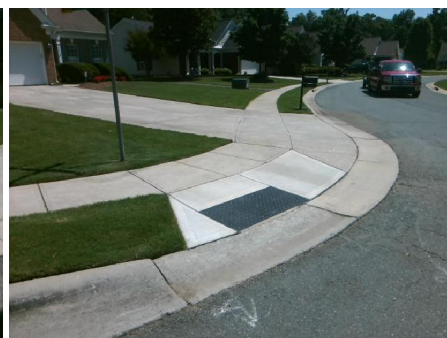
| Compliance | Description | Data | Compliance | Description | Data |
|---|---|---|---|---|---|
| | | | Yes | Surface Condition? (G/P) | Good |
