# Access Compliance Report

## Public Rights-of-Way

### (Curb Ramps)

Intersection ID: 21987	Main Street: OLD_PROVIDENCE_RD	Cross Street: OLD_PROVIDENCE_LN	Location: SW
ADA ID: 0F5608F950AB	Ramp Type: Perp	Initial Pass/Fail: Fail	Overall Compliance: No
		Severity Score: 37.5

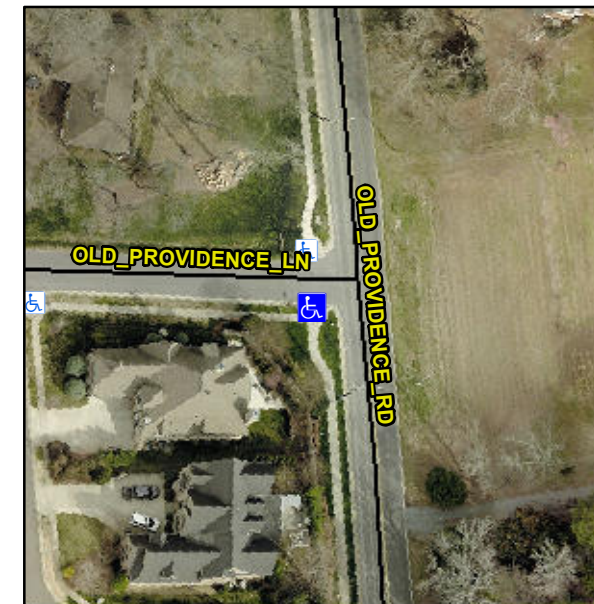
**Not Found, R304.5.3**

Compliance	Description	Data	Compliance	Description	Data
N/A	Ramp Length (in)	338.0	Yes	Ramp Slope (%)	9.1
Yes	Ramp Width (in)	48.5	No	Ramp XSlope (%)	8.6
N/A	Flare Type LT	N/A	N/A	Flare Type RT	N/A
N/A	Flare Slope LT (%)	N/A	N/A	Flare Slope RT (%)	N/A
N/A	Flare Traversable LT?	N/A	N/A	Flare Traversable RT?	N/A
N/A	Landing Length (in)	N/A	N/A	DWS Provided?	N/A
N/A	Landing Width (in)	N/A	N/A	DWS Contrast?	N/A
N/A	Landing Slope (%)	N/A	N/A	DWS Length (in)	N/A
N/A	Landing X Slope (%)	N/A	N/A	DWS Full Width?	N/A
N/A	Landing Curb? (Y/N)	N/A	N/A	DWS Offset (in)	N/A
N/A	Shared Landing?	N/A			
N/A	Gutter Ponding?	N/A	N/A	Gutter Slope (%)	N/A
N/A	Gutter Lip Ht (in)	N/A	N/A	Gutter X Slope (%)	N/A
N/A	Painted X Walk1?	No	N/A	Painted X Walk2?	N/A
	X Walk 1 Direction	To N		X Walk 2 Direction	N/A
N/A	X Walk 1 Width (in)	N/A	N/A	X Walk 2 Width (in)	N/A
	X Walk 1 Slope (%)	1.7		X Walk 2 Slope (%)	N/A
	X Walk 1 X Slope (%)	9.4		X Walk 2 X Slope (%)	N/A

**Remove & Replace Entire Ramp.**
