Access Compliance Report

Public Rights-of-Way

(Curb Ramps)

Intersection ID: N/A	Main Street: S_CLARKSON_ST	Cross Street: DUNBAR_ST	Location: W
ADA ID: 0F64EBC8AC8A	Ramp Type: Perp	Initial Pass/Fail: Pass	Overall Compliance: No
		Severity Score: 0

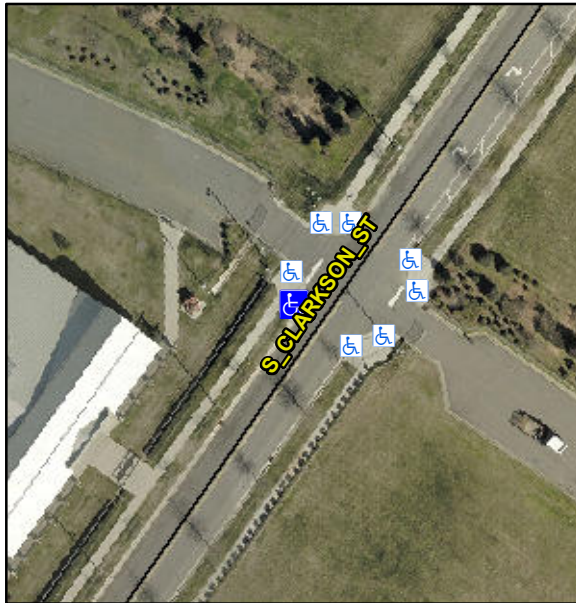
Not Found, R302.3, R402.2

Compliance	Description	Data	Compliance	Description	Data
N/A	Ramp Length (in)	96.0	Yes	Ramp Slope (%)	5.1
Yes	Ramp Width (in)	48.0	Yes	Ramp XSlope (%)	1.3
N/A	Flare Type LT	Sloped	N/A	Flare Type RT	N/A
N/A	Flare Slope LT (%)	5.2	Yes	Flare Slope RT (%)	5.9
N/A	Flare Traversable LT?	No	N/A	Flare Traversable RT?	Yes
Yes	Landing Length (in)	60.0	Yes	DWS Provided?	Yes
Yes	Landing Width (in)	48.0	Yes	DWS Contrast?	Yes
Yes	Landing Slope (%)	1.2	Yes	DWS Length (in)	24.0
Yes	Landing X Slope (%)	1.2	Yes	DWS Full Width?	Yes
N/A	Landing Curb? (Y/N)	No	Yes	DWS Offset (in)	1.5
N/A	Shared Landing?	No			
Yes	Gutter Ponding?	No	Yes	Gutter Slope (%)	1.1
Yes	Gutter Lip Ht (in)	0.0	Yes	Gutter X Slope (%)	0.8
N/A	Painted X Walk1?	No	N/A	Painted X Walk2?	N/A
	X Walk 1 Direction	To SE		X Walk 2 Direction	N/A
N/A	X Walk 1 Width (in)	N/A	N/A	X Walk 2 Width (in)	N/A
	X Walk 1 Slope (%)	2.3		X Walk 2 Slope (%)	N/A
	X Walk 1 X Slope (%)	1.4		X Walk 2 X Slope (%)	N/A

N/A	Ramp inside XWalk1?	N/A	N/A	Ramp inside XWalk2?	N/A
	Road Slope (%)	N/A	N/A	Clear Space?	Yes
	Road X Slope (%)	N/A	N/A	Clear Space to XWalk (in)	N/A
Yes	Any Obstructions?	Yes	Yes	Storm Grate/Utility Hazard?	No
	Obstruction Type			Storm Grate/Utility Type	
				PULLBOX LIP 0.5	N/A
			Yes	Surface Condition? (G/P)	Good

**Remove & Replace Entire Ramp.
Utility Present.**
