Access Compliance Report Public Rights-of-Way (Curb Ramps)

Intersection ID: N/A Cross Street: WILLIAM REYNOLDS DR Location: Main Street: JAMES RD NE **Overall Compliance: No** 0 ADA ID: 0F66E4F1D416 Ramp Type: Combination2Diag Initial Pass/Fail: Fail **Severity Score:**

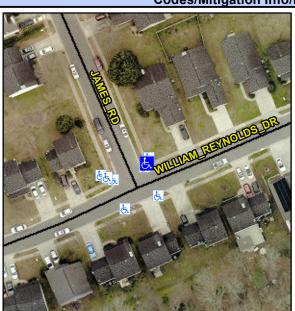
Compl	iance Description	Data	Compl	iance Description
N/A	Ramp Length LT (in)	45.0	N/A	Ramp Length RT (in)
Yes	Ramp Width LT (in)	48.0	No	Ramp Width RT (in)
Yes	Ramp Slope LT (%)	2.1	Yes	Ramp Slope RT (%)
No	Ramp XSlope LT (%)	2.3	Yes	Ramp XSlope RT (%)
N/A	Ramp Length (in)	49.5	Yes	Ramp Slope (%)
Yes	Ramp Width (in)	49.0	No	Ramp XSlope (%)
N/A	Flare Type LT	N/A	N/A	Flare Type RT
N/A	Flare Slope LT (%)	N/A	N/A	Flare Slope RT (%)
N/A	Flare Traversable LT?	N/A	N/A	Flare Traversable RT?
N/A	Landing Length (in)	N/A	N/A	DWS Provided?
N/A	Landing Width (in)	N/A	N/A	DWS Contrast?
N/A	Landing Slope (%)	N/A	N/A	DWS Length (in)
N/A	Landing X Slope (%)	N/A	N/A	DWS Full Width?
N/A	Landing Curb? (Y/N)	N/A	N/A	DWS Offset (in)
N/A	Shared Landing?	N/A		
N/A	Gutter Ponding?	N/A	N/A	Gutter Slope (%)
N/A	Gutter Lip Ht (in)	N/A	N/A	Gutter X Slope (%)
N/A	Painted X Walk1?	No	N/A	Painted X Walk2?
	X Walk 1 Direction	To W		X Walk 2 Direction

StopSign JAMES RD None WILLIAM REYNOLDS DR Possible Solutions: Remove & Replace Curb Ramp With Two New Directional Ramps or Equivalent. Surveyor Notes: N/A PROW/ADA: Not Found, R304.5.1, R304.5.3
