Access Compliance Report

Public Rights-of-Way

(Curb Ramps)

Intersection ID: 20654	Main Street: E_INDEPENDENCE_BV	Cross Street: SARDIS_RD_NORTH	Location: NW
ADA ID: 0F69097E8720	Ramp Type: Perp	Initial Pass/Fail: Fail	Overall Compliance: No
Severity Score: 10			
Codes/Mitigation Info/Possible Solution		Field Measurements/Component Compliance

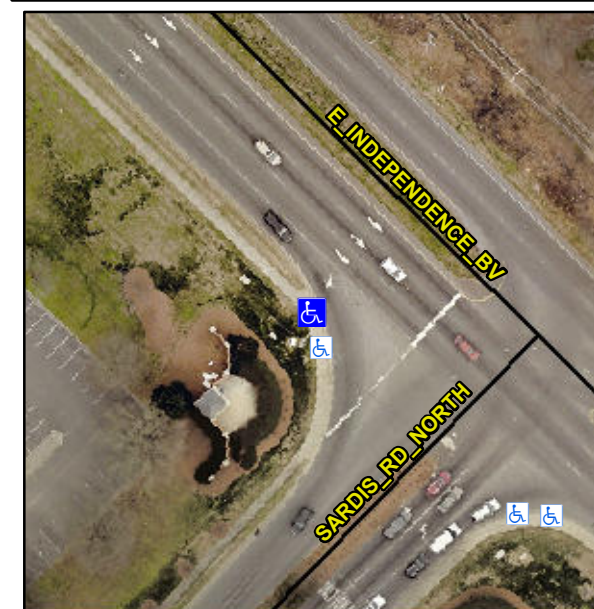
Not Found, R304.5.1, R304.5.3

Compliance	Description	Data	Compliance	Description	Data
N/A	Ramp Length (in)	39.0	Yes	Ramp Slope (%)	5.8
No	Ramp Width (in)	45.5	No	Ramp XSlope (%)	3.9
N/A	Flare Type LT	N/A	N/A	Flare Type RT	N/A
N/A	Flare Slope LT (%)	N/A	N/A	Flare Slope RT (%)	N/A
N/A	Flare Traversable LT?	N/A	N/A	Flare Traversable RT?	N/A
N/A	Landing Length (in)	N/A	N/A	DWS Provided?	N/A
N/A	Landing Width (in)	N/A	N/A	DWS Contrast?	N/A
N/A	Landing Slope (%)	N/A	N/A	DWS Length (in)	N/A
N/A	Landing X Slope (%)	N/A	N/A	DWS Full Width?	N/A
N/A	Landing Curb? (Y/N)	N/A	N/A	DWS Offset (in)	N/A
N/A	Shared Landing?	N/A			
N/A	Gutter Ponding?	N/A	N/A	Gutter Slope (%)	N/A
N/A	Gutter Lip Ht (in)	N/A	N/A	Gutter X Slope (%)	N/A
N/A	Painted X Walk1?	No	N/A	Painted X Walk2?	N/A
	X Walk 1 Direction	To NE		X Walk 2 Direction	N/A
N/A	X Walk 1 Width (in)	N/A	N/A	X Walk 2 Width (in)	N/A
	X Walk 1 Slope (%)	0.4		X Walk 2 Slope (%)	N/A
	X Walk 1 X Slope (%)	2.3		X Walk 2 X Slope (%)	N/A

N/A	Ramp inside XWalk1?	N/A	N/A	Ramp inside XWalk2?	N/A
	Road Slope (%)	N/A	N/A	Clear Space?	N/A
	Road X Slope (%)	N/A	N/A	Clear Space to XWalk (in)	N/A
N/A	Any Obstructions?	N/A	N/A	Storm Grate/Utility Hazard?	N/A
	Obstruction Type			Storm Grate/Utility Type	
		N/A			N/A
			Yes	Surface Condition? (G/P)	Good

Remove & Replace Entire Ramp.
