Access Compliance Report

Public Rights-of-Way

(Curb Ramps)

Intersection ID: 15477	Main Street: W_TYVOLA_RD	Cross Street: CASCADE_POINTE_BV	Location:	N
ADA ID: 0F72234F37B2	Ramp Type: Perp	Initial Pass/Fail: Fail	Overall Compliance: No	Severity Score: 22.5

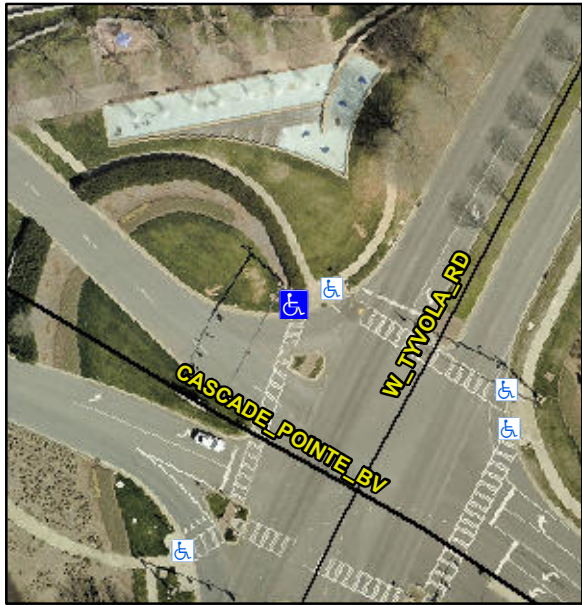
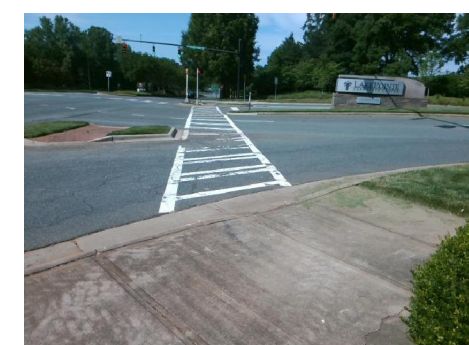
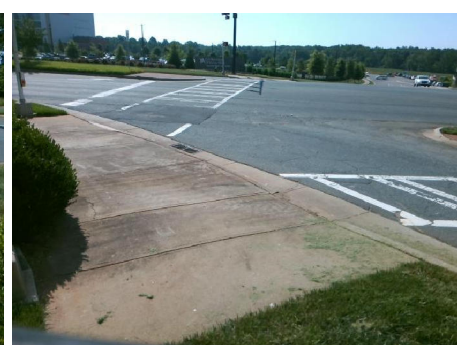
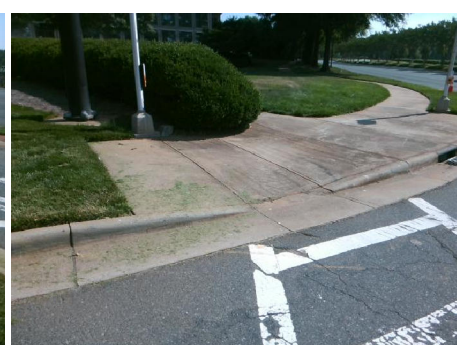
Possible Solutions:		Remove & Replace Entire Ramp.					
	Surveyor Notes:		N/A					
	PROW/ADA:		Not Found, R304.5.1, R304.2.2, R304.5.3					
	Street 1 Name		CASCADE POINTE BV					
	Stop Condition-Street 2		Signal					
	Street 2 Name		N/A					
	Stop Condition-Street 1		N/A					
	Total Cost:		\$ 1850.00					
			Compliance	Description	Data	Compliance	Description	Data
			N/A	Ramp Length (in)	78.0	No	Ramp Slope (%)	10.0
			No	Ramp Width (in)	42.0	No	Ramp XSlope (%)	3.2
			N/A	Flare Type LT	N/A	N/A	Flare Type RT	N/A
			N/A	Flare Slope LT (%)	N/A	N/A	Flare Slope RT (%)	N/A
			N/A	Flare Traversable LT?	N/A	N/A	Flare Traversable RT?	N/A
			N/A	Landing Length (in)	N/A	N/A	DWS Provided?	N/A
			N/A	Landing Width (in)	N/A	N/A	DWS Contrast?	N/A
			N/A	Landing Slope (%)	N/A	N/A	DWS Length (in)	N/A
			N/A	Landing X Slope (%)	N/A	N/A	DWS Full Width?	N/A

N/A	Landing Curb? (Y/N)	N/A	N/A	DWS Offset (in)	N/A
			N/A	Shared Landing?	N/A			
			N/A	Gutter Ponding?	N/A	N/A	Gutter Slope (%)	N/A
			N/A	Gutter Lip Ht (in)	N/A	N/A	Gutter X Slope (%)	N/A
			N/A	Painted X Walk1?	Yes	N/A	Painted X Walk2?	N/A
				X Walk 1 Direction	To SW		X Walk 2 Direction	N/A
			N/A	X Walk 1 Width (in)	72.0	N/A	X Walk 2 Width (in)	N/A
				X Walk 1 Slope (%)	1.7		X Walk 2 Slope (%)	N/A
				X Walk 1 X Slope (%)	2.6		X Walk 2 X Slope (%)	N/A
			N/A	Ramp inside XWalk1?	Yes	N/A	Ramp inside XWalk2?	N/A
				Road Slope (%)	N/A	N/A	Clear Space?	N/A
				Road X Slope (%)	N/A	N/A	Clear Space to XWalk (in)	N/A
			N/A	Any Obstructions?	N/A	N/A	Storm Grate/Utility Hazard?	N/A
				Obstruction Type			Storm Grate/Utility Type	
					N/A			N/A
						Yes	Surface Condition? (G/P)	Good
