Access Compliance Report

Public Rights-of-Way

(Curb Ramps)

Intersection ID: 16587	Main Street: NORTH_FALLS_DR	Cross Street: W_TYVOLA_RD	Location: NE
ADA ID: 0F72BA075678	Ramp Type: PerpDiag	Initial Pass/Fail: Fail	Overall Compliance: No
Severity Score: 12.5			
Codes/Mitigation Info/Possible Solution		Field Measurements/Component Compliance

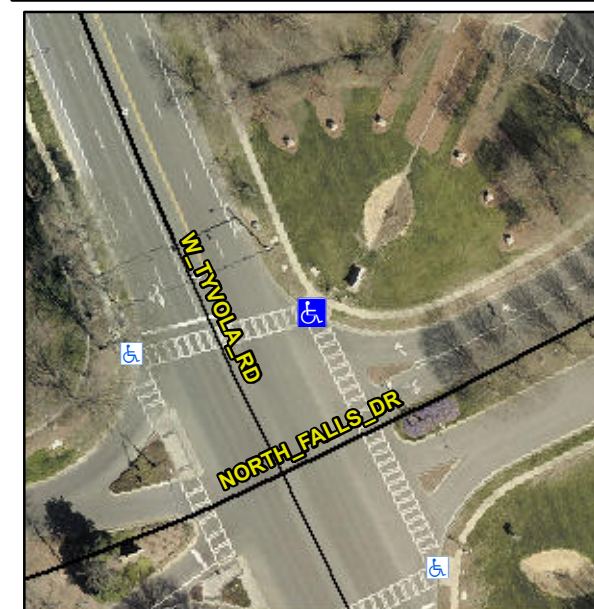
Not Found, R304.5.3

Compliance	Description	Data	Compliance	Description	Data
N/A	Ramp Length (in)	125.0	Yes	Ramp Slope (%)	6.5
Yes	Ramp Width (in)	63.0	No	Ramp XSlope (%)	6.8
N/A	Flare Type LT	N/A	N/A	Flare Type RT	N/A
N/A	Flare Slope LT (%)	N/A	N/A	Flare Slope RT (%)	N/A
N/A	Flare Traversable LT?	N/A	N/A	Flare Traversable RT?	N/A
N/A	Landing Length (in)	N/A	N/A	DWS Provided?	N/A
N/A	Landing Width (in)	N/A	N/A	DWS Contrast?	N/A
N/A	Landing Slope (%)	N/A	N/A	DWS Length (in)	N/A
N/A	Landing X Slope (%)	N/A	N/A	DWS Full Width?	N/A
N/A	Landing Curb? (Y/N)	N/A	N/A	DWS Offset (in)	N/A
N/A	Shared Landing?	N/A			
N/A	Gutter Ponding?	N/A	N/A	Gutter Slope (%)	N/A
N/A	Gutter Lip Ht (in)	N/A	N/A	Gutter X Slope (%)	N/A
N/A	Painted X Walk1?	Yes	N/A	Painted X Walk2?	Yes
	X Walk 1 Direction	To W		X Walk 2 Direction	To S
N/A	X Walk 1 Width (in)	112.0	N/A	X Walk 2 Width (in)	107.0
	X Walk 1 Slope (%)	2.7		X Walk 2 Slope (%)	3.5
	X Walk 1 X Slope (%)	3.3		X Walk 2 X Slope (%)	3.3

N/A	Ramp inside XWalk1?	Yes	N/A	Ramp inside XWalk2?	Yes
	Road Slope (%)	4.2	N/A	Clear Space?	N/A
	Road X Slope (%)	2.2	N/A	Clear Space to XWalk (in)	N/A
N/A	Any Obstructions?	N/A	N/A	Storm Grate/Utility Hazard?	N/A
	Obstruction Type			Storm Grate/Utility Type	
		N/A			N/A
		Yes		Surface Condition? (G/P)	Good

Remove & Replace Curb Ramp With Two New Directional Ramps or Equivalent.

Total Cost: \$ 3200.00
