# Access Compliance Report

## Public Rights-of-Way

### (Curb Ramps)

Intersection ID: 14253	Main Street: LUTHER_ST	Cross Street: S_TORRENCE_ST	Location: SE
ADA ID: 0F743D13CCC2	Ramp Type: PerpDiag	Initial Pass/Fail: Fail	Overall Compliance: No
			Severity Score: 33.75

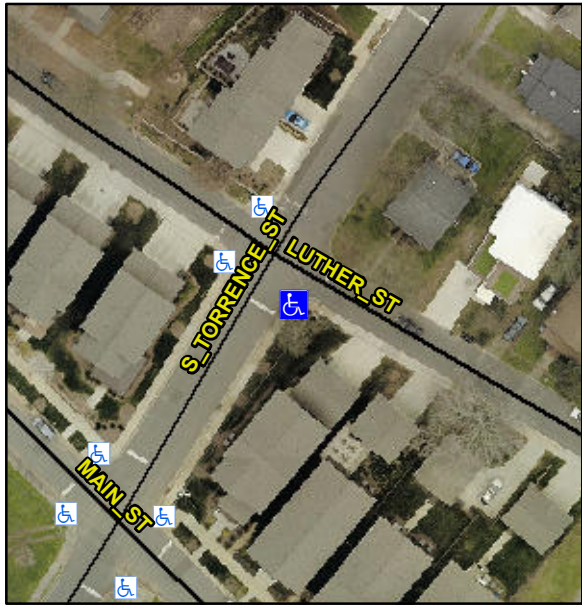
Possible Solutions:		Compliance	Description	Data	Compliance	Description	Data
	Remove & Replace Curb Ramp With Two New Directional Ramps or Equivalent.		N/A	Ramp Length (in)	55.0	Yes	Ramp Slope (%)	6.9
			No	Ramp Width (in)	36.0	No	Ramp XSlope (%)	7.2
			N/A	Flare Type LT	N/A	N/A	Flare Type RT	N/A
			N/A	Flare Slope LT (%)	N/A	N/A	Flare Slope RT (%)	N/A
			N/A	Flare Traversable LT?	N/A	N/A	Flare Traversable RT?	N/A
			N/A	Landing Length (in)	N/A	N/A	DWS Provided?	N/A
			N/A	Landing Width (in)	N/A	N/A	DWS Contrast?	N/A
			N/A	Landing Slope (%)	N/A	N/A	DWS Length (in)	N/A
			N/A	Landing X Slope (%)	N/A	N/A	DWS Full Width?	N/A
Surveyor Notes:	N/A		N/A	Landing Curb? (Y/N)	N/A	N/A	DWS Offset (in)	N/A
			N/A	Shared Landing?	N/A			
	PROW/ADA:		N/A	Gutter Ponding?	N/A	N/A	Gutter Slope (%)	N/A
	Not Found, R304.5.1, R304.5.3		N/A	Gutter Lip Ht (in)	N/A	N/A	Gutter X Slope (%)	N/A

N/A	Painted X Walk1?	No	N/A	Painted X Walk2?	No
				X Walk 1 Direction	To NE		X Walk 2 Direction	To NW
			N/A	X Walk 1 Width (in)	N/A	N/A	X Walk 2 Width (in)	N/A
				X Walk 1 Slope (%)	7.8		X Walk 2 Slope (%)	1.8
				X Walk 1 X Slope (%)	2.6		X Walk 2 X Slope (%)	8.5
			N/A	Ramp inside XWalk1?	N/A	N/A	Ramp inside XWalk2?	N/A
Street 1 Name LUTHER ST Stop Condition-Street 2 StopSign Street 2 Name S TORRENCE ST Stop Condition-Street 1 StopSign				Road Slope (%)	6.1	N/A	Clear Space?	N/A
				Road X Slope (%)	4.1	N/A	Clear Space to XWalk (in)	N/A
			N/A	Any Obstructions?	N/A	N/A	Storm Grate/Utility Hazard?	N/A
				Obstruction Type			Storm Grate/Utility Type	
					N/A			N/A
						Yes	Surface Condition? (G/P)	Good
	Total Cost:		\$	3200.00
