Access Compliance Report

Public Rights-of-Way

(Curb Ramps)

Intersection ID: 15174	Main Street: DILWORTH_RD_WEST	Cross Street: IDEAL_WY	Location: SE
ADA ID: 0F7991671757	Ramp Type: BlendTrans1	Initial Pass/Fail: Fail	Overall Compliance: No
		Severity Score: 1.25

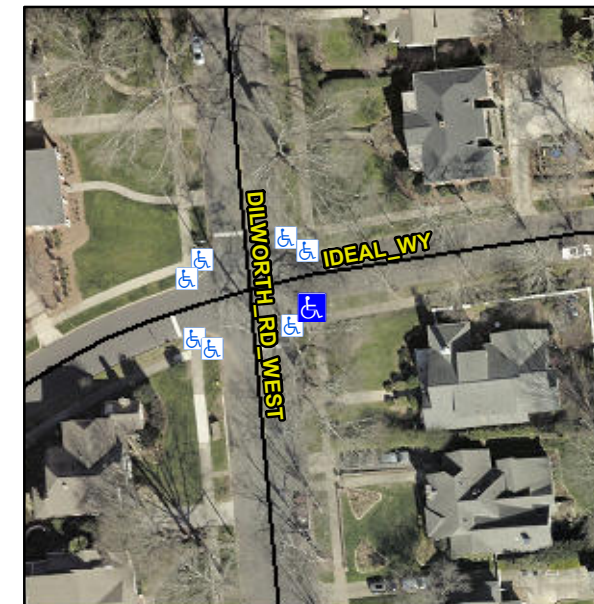
Not Found, R304.5.3

Compliance	Description	Data	Compliance	Description	Data
N/A	Ramp Length (in)	70.5	Yes	BlendTrans Slope (%)	2.1
Yes	Ramp Width (in)	68.0	No	BlendTrans XSlope (%)	3.2
N/A	Flare Type LT	N/A	N/A	Flare Type RT	N/A
N/A	Flare Slope LT (%)	N/A	N/A	Flare Slope RT (%)	N/A
N/A	Flare Traversable LT?	N/A	N/A	Flare Traversable RT?	N/A
N/A	Landing Length (in)	N/A	N/A	DWS Provided?	N/A
N/A	Landing Width (in)	N/A	N/A	DWS Contrast?	N/A
N/A	Landing Slope (%)	N/A	N/A	DWS Length (in)	N/A
N/A	Landing X Slope (%)	N/A	N/A	DWS Full Width?	N/A
N/A	Landing Curb? (Y/N)	N/A	N/A	DWS Offset (in)	N/A
N/A	Shared Landing?	N/A			
N/A	Gutter Ponding?	N/A	N/A	Gutter Slope (%)	N/A
N/A	Gutter Lip Ht (in)	N/A	N/A	Gutter X Slope (%)	N/A
N/A	Painted X Walk1?	No	N/A	Painted X Walk2?	N/A
	X Walk 1 Direction	To N		X Walk 2 Direction	N/A
	X Walk 1 Width (in)	N/A		X Walk 2 Width (in)	N/A
	X Walk 1 Slope (%)	3.9		X Walk 2 Slope (%)	N/A
	X Walk 1 X Slope (%)	0.5		X Walk 2 X Slope (%)	N/A

N/A	Ramp inside XWalk1?	N/A	N/A	Ramp inside XWalk2?	N/A
	Road Slope (%)	0.5		Clear Space?	N/A
	Road X Slope (%)	3.9	N/A	Clear Space to XWalk (in)	N/A
N/A	Any Obstructions?	N/A	N/A	Storm Grate/Utility Hazard?	N/A
	Obstruction Type			Storm Grate/Utility Type	
		N/A			N/A
			Yes	Surface Condition? (G/P)	Good
			No	Curb Slope (%)	11.8

Remove & Replace Curb Ramp With Two New Directional Ramps or Equivalent.
