Access Compliance Report Public Rights-of-Way (Curb Ramps)

Intersection ID: 43489Main Street:PRESCOTT_HILL_AVCross Street:CRESCENT_RUN_CTLocation:NADA ID: 0F7A45FA1351Ramp Type:PerpDiagInitial Pass/Fail:FailOverall Compliance:NoSeverity Score:22.5

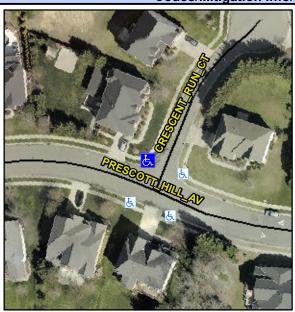
Not Found, R304.5.1, R304.2.2, R304.5.3

| Field Measurements/Component Compliance | | | | | |
|---|---|---|---|---|---|
| N/A | Ramp Length (in) | 48.0 | No | Ramp Slope (%) | 8.4 |
| No | Ramp Width (in) | 44.0 | No | Ramp XSlope (%) | 2.5 |

Remove & Replace Curb Ramp With Two New Directional Ramps or Equivalent.
