# Access Compliance Report

## Public Rights-of-Way

### (Curb Ramps)

Intersection ID: 2509	Main Street: LYNNEWOOD_GLEN_DR	Cross Street: WHITEGATE_LN	Location:	N
ADA ID: 0F7E97DB2076	Ramp Type: Perp	Initial Pass/Fail: Fail	Overall Compliance: No	Severity Score: 12.5
Codes/Mitigation Info/Possible Solution		Field Measurements/Component Compliance

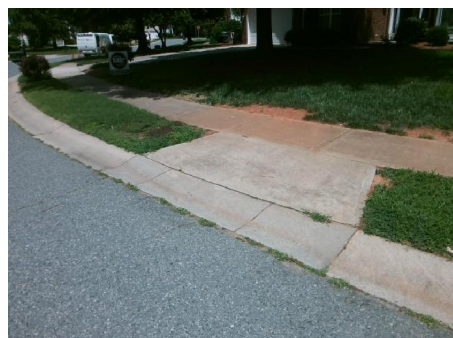
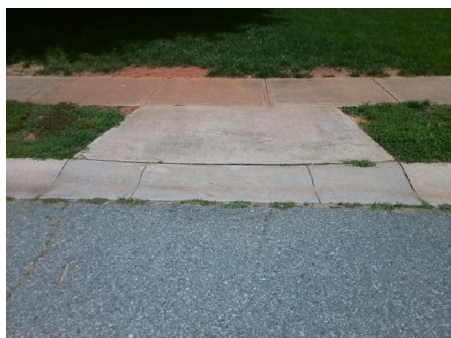
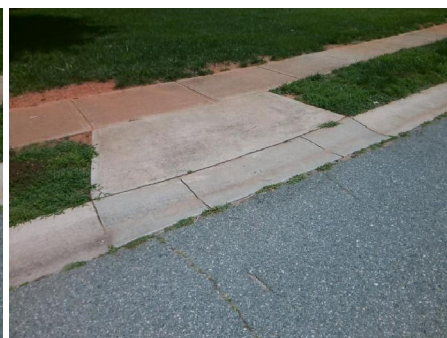
**Not Found, R304.2.2**

Compliance	Description	Data	Compliance	Description	Data
N/A	Ramp Length (in)	48.0	No	Ramp Slope (%)	11.3
Yes	Ramp Width (in)	60.0	Yes	Ramp XSlope (%)	0.2
N/A	Flare Type LT	N/A	N/A	Flare Type RT	N/A
N/A	Flare Slope LT (%)	N/A	N/A	Flare Slope RT (%)	N/A
N/A	Flare Traversable LT?	N/A	N/A	Flare Traversable RT?	N/A
N/A	Landing Length (in)	N/A	N/A	DWS Provided?	N/A
N/A	Landing Width (in)	N/A	N/A	DWS Contrast?	N/A
N/A	Landing Slope (%)	N/A	N/A	DWS Length (in)	N/A
N/A	Landing X Slope (%)	N/A	N/A	DWS Full Width?	N/A
N/A	Landing Curb? (Y/N)	N/A	N/A	DWS Offset (in)	N/A
N/A	Shared Landing?	N/A			
N/A	Gutter Ponding?	N/A	N/A	Gutter Slope (%)	N/A
N/A	Gutter Lip Ht (in)	N/A	N/A	Gutter X Slope (%)	N/A
N/A	Painted X Walk1?	No	N/A	Painted X Walk2?	N/A
	X Walk 1 Direction	To S		X Walk 2 Direction	N/A
N/A	X Walk 1 Width (in)	N/A	N/A	X Walk 2 Width (in)	N/A
	X Walk 1 Slope (%)	0.7		X Walk 2 Slope (%)	N/A
	X Walk 1 X Slope (%)	1.1		X Walk 2 X Slope (%)	N/A

N/A	Ramp inside XWalk1?	N/A	N/A	Ramp inside XWalk2?	N/A
	Road Slope (%)	N/A	N/A	Clear Space?	N/A
	Road X Slope (%)	N/A	N/A	Clear Space to XWalk (in)	N/A
N/A	Any Obstructions?	N/A	N/A	Storm Grate/Utility Hazard?	N/A
	Obstruction Type			Storm Grate/Utility Type	
		N/A			N/A
			Yes	Surface Condition? (G/P)	Good

**Remove & Replace Entire Ramp.**

Total Cost: \$ 1850.00
