Access Compliance Report

Public Rights-of-Way

(Curb Ramps)

Intersection ID: 21161	Main Street: FOLGER_DR	Cross Street: PROVIDENCE_RD	Location: SE
ADA ID: 0F8553E8EE09	Ramp Type: Perp	Initial Pass/Fail: Fail	Overall Compliance: No
Codes/Mitigation Info/Possible Solution			Severity Score: 25
			Field Measurements/Component Compliance

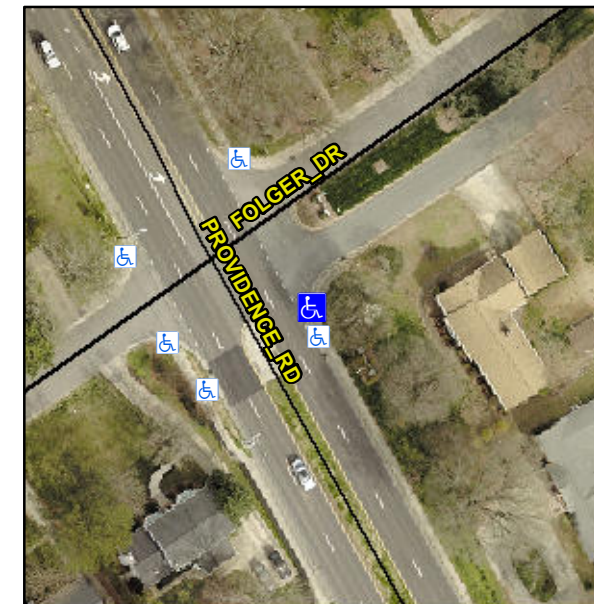
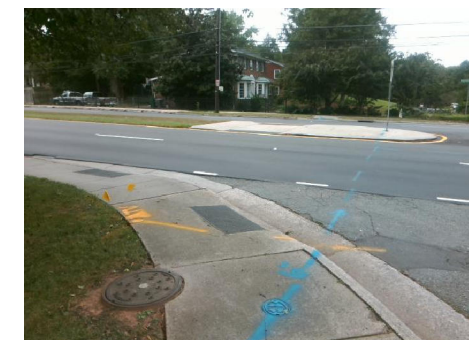
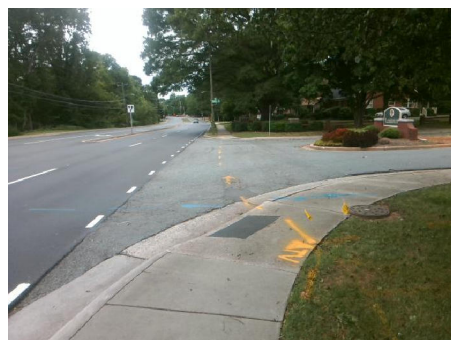
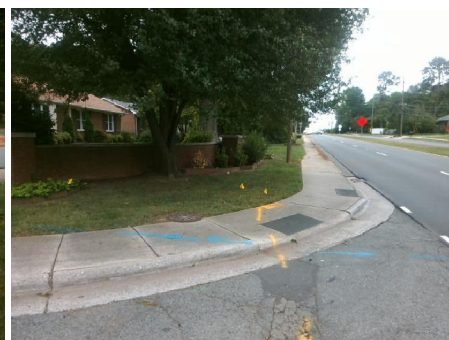
Not Found, R304.2.2

Compliance	Description	Data	Compliance	Description	Data
N/A	Ramp Length (in)	61.0	No	Ramp Slope (%)	12.7
Yes	Ramp Width (in)	48.0	Yes	Ramp XSlope (%)	1.3
N/A	Flare Type LT	N/A	N/A	Flare Type RT	N/A
N/A	Flare Slope LT (%)	N/A	N/A	Flare Slope RT (%)	N/A
N/A	Flare Traversable LT?	N/A	N/A	Flare Traversable RT?	N/A
N/A	Landing Length (in)	N/A	N/A	DWS Provided?	N/A
N/A	Landing Width (in)	N/A	N/A	DWS Contrast?	N/A
N/A	Landing Slope (%)	N/A	N/A	DWS Length (in)	N/A
N/A	Landing X Slope (%)	N/A	N/A	DWS Full Width?	N/A
N/A	Landing Curb? (Y/N)	N/A	N/A	DWS Offset (in)	N/A
N/A	Shared Landing?	N/A			
N/A	Gutter Ponding?	N/A	N/A	Gutter Slope (%)	N/A
N/A	Gutter Lip Ht (in)	N/A	N/A	Gutter X Slope (%)	N/A
N/A	Painted X Walk1?	No	N/A	Painted X Walk2?	N/A
	X Walk 1 Direction	To NW		X Walk 2 Direction	N/A
N/A	X Walk 1 Width (in)	N/A	N/A	X Walk 2 Width (in)	N/A
	X Walk 1 Slope (%)	2.0		X Walk 2 Slope (%)	N/A
	X Walk 1 X Slope (%)	1.1		X Walk 2 X Slope (%)	N/A

N/A	Ramp inside XWalk1?	N/A	N/A	Ramp inside XWalk2?	N/A
	Road Slope (%)	N/A	N/A	Clear Space?	N/A
	Road X Slope (%)	N/A	N/A	Clear Space to XWalk (in)	N/A
N/A	Any Obstructions?	N/A	N/A	Storm Grate/Utility Hazard?	N/A
	Obstruction Type			Storm Grate/Utility Type	
		N/A			N/A
			Yes	Surface Condition? (G/P)	Good

Remove & Replace Entire Ramp.
