Access Compliance Report

Public Rights-of-Way

(Curb Ramps)

Intersection ID: 10031975	Main Street: MONROE_RD	Cross Street: N/A	Location: NE
ADA ID: 0F85BF11E00C	Ramp Type: Perp	Initial Pass/Fail: Fail	Overall Compliance: No
Severity Score: 12.5			
Codes/Mitigation Info/Possible Solution		Field Measurements/Component Compliance

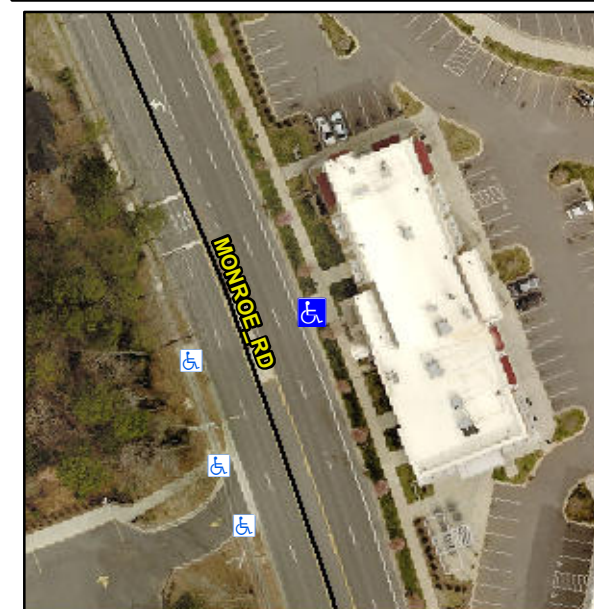
Compliance	Description	Data	Compliance	Description	Data
N/A	Ramp Length (in)	96.0	No	Ramp Slope (%)	10.6
Yes	Ramp Width (in)	48.0	Yes	Ramp XSlope (%)	0.1
N/A	Flare Type LT	N/A	N/A	Flare Type RT	N/A
N/A	Flare Slope LT (%)	N/A	N/A	Flare Slope RT (%)	N/A
N/A	Flare Traversable LT?	N/A	N/A	Flare Traversable RT?	N/A
N/A	Landing Length (in)	N/A	N/A	DWS Provided?	N/A
N/A	Landing Width (in)	N/A	N/A	DWS Contrast?	N/A
N/A	Landing Slope (%)	N/A	N/A	DWS Length (in)	N/A
N/A	Landing X Slope (%)	N/A	N/A	DWS Full Width?	N/A
N/A	Landing Curb? (Y/N)	N/A	N/A	DWS Offset (in)	N/A
N/A	Shared Landing?	N/A			
N/A	Gutter Ponding?	N/A	N/A	Gutter Slope (%)	N/A
N/A	Gutter Lip Ht (in)	N/A	N/A	Gutter X Slope (%)	N/A
N/A	Painted X Walk1?	No	N/A	Painted X Walk2?	N/A
	X Walk 1 Direction	To SW		X Walk 2 Direction	N/A
N/A	X Walk 1 Width (in)	N/A	N/A	X Walk 2 Width (in)	N/A
	X Walk 1 Slope (%)	1.9		X Walk 2 Slope (%)	N/A
	X Walk 1 X Slope (%)	1.8		X Walk 2 X Slope (%)	N/A

N/A	Ramp inside XWalk1?	N/A	N/A	Ramp inside XWalk2?	N/A
	Road Slope (%)	N/A	N/A	Clear Space?	N/A
	Road X Slope (%)	N/A	N/A	Clear Space to XWalk (in)	N/A
N/A	Any Obstructions?	N/A	N/A	Storm Grate/Utility Hazard?	N/A
	Obstruction Type			Storm Grate/Utility Type	
		N/A			N/A
			Yes	Surface Condition? (G/P)	Good

Possible Solutions:

Remove & Replace Entire Ramp.

R304.2.2

\$ 1850.00
