Access Compliance Report

Public Rights-of-Way

(Curb Ramps)

Intersection ID: 12721	Main Street: S_CHURCH_ST	Cross Street: W_HILL_ST	Location: S
ADA ID: 0F8620135A2D	Ramp Type: Para	Initial Pass/Fail: Pass	Overall Compliance: No
Severity Score: 0.25			
Codes/Mitigation Info/Possible Solution		Field Measurements/Component Compliance

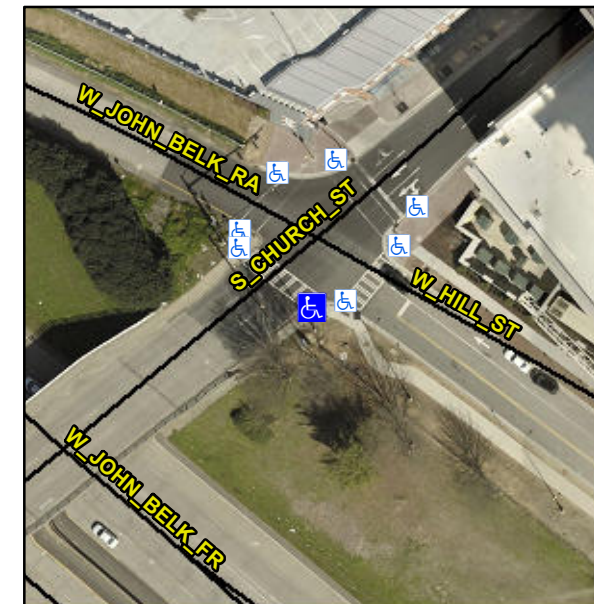
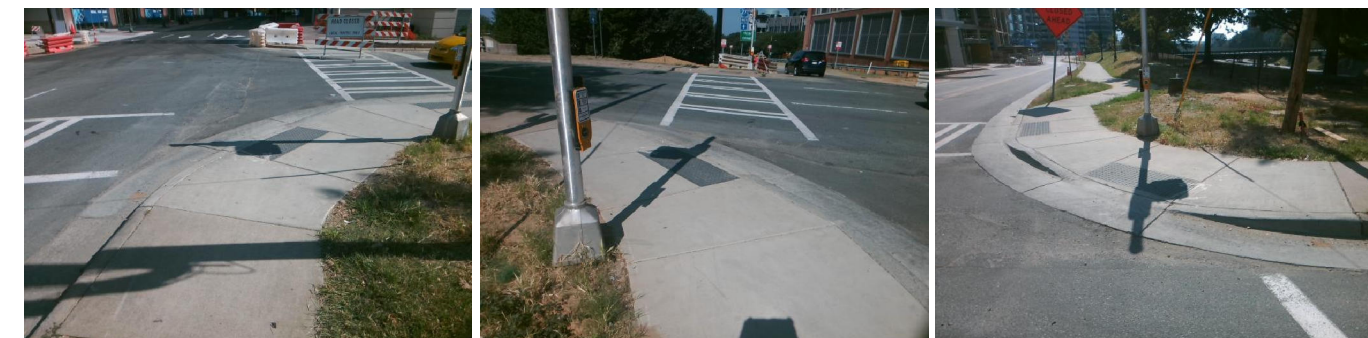
Compliance	Description	Data	Compliance	Description	Data
N/A	Ramp Length LT (in)	36.0	N/A	Ramp Length RT (in)	48.0
Yes	Ramp Width LT (in)	70.5	Yes	Ramp Width RT (in)	61.0
Yes	Ramp Slope LT (%)	6.2	Yes	Ramp Slope RT (%)	7.5
Yes	Ramp XSlope LT (%)	1.2	No	Ramp XSlope RT (%)	4.6
Yes	Landing Length (in)	70.5	Yes	DWS Provided?	Yes
Yes	Landing Width (in)	60.0	Yes	DWS Contrast?	Yes
No	Landing Slope (%)	2.4	Yes	DWS Length (in)	24.0
Yes	Landing X Slope (%)	0.7	Yes	DWS Full Width?	Yes
N/A	Landing Curb? (Y/N)	No	No	DWS Offset (in)	5.0
N/A	Shared Landing?	No			
Yes	Gutter Ponding?	No	Yes	Gutter Slope (%)	0.0
Yes	Gutter Lip Ht (in)	0.0	Yes	Gutter X Slope (%)	1.0
N/A	Painted X Walk1?	Yes	N/A	Painted X Walk2?	N/A
	X Walk 1 Direction	To NW		X Walk 2 Direction	N/A
N/A	X Walk 1 Width (in)	100.0	N/A	X Walk 2 Width (in)	N/A
	X Walk 1 Slope (%)	1.5		X Walk 2 Slope (%)	N/A
	X Walk 1 X Slope (%)	0.4		X Walk 2 X Slope (%)	N/A
Yes	Ramp inside XWalk1?	Yes	N/A	Ramp inside XWalk2?	N/A

Road Slope (%)	N/A	N/A	Clear Space?	Yes
	Road X Slope (%)	N/A	N/A	Clear Space to XWalk (in)	N/A
Yes	Any Obstructions?	No	Yes	Storm Grate/Utility Hazard?	No
	Obstruction Type			Storm Grate/Utility Type	
		N/A			N/A
			Yes	Surface Condition? (G/P)	Good
			N/A	Curb Slope (%)	10.0

Possible Solutions:

Remove & Replace Entire Ramp.
