Access Compliance Report

Public Rights-of-Way

(Curb Ramps)

Intersection ID: 31252	Main Street: MORNINGVIEW_CT	Cross Street: SUNSET_RIDGE_CT	Location: NE
ADA ID: 0F869FCE4610	Ramp Type: Perp	Initial Pass/Fail: Fail	Overall Compliance: No
Severity Score: 0			
Codes/Mitigation Info/Possible Solution		Field Measurements/Component Compliance

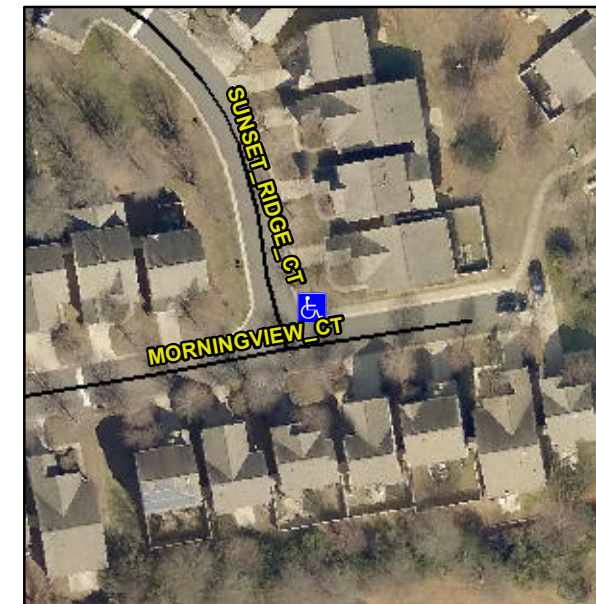
Compliance	Description	Data	Compliance	Description	Data
N/A	Ramp Length (in)	47.5	Yes	Ramp Slope (%)	6.4
Yes	Ramp Width (in)	49.5	Yes	Ramp XSlope (%)	1.2
N/A	Flare Type LT	N/A	N/A	Flare Type RT	N/A
N/A	Flare Slope LT (%)	N/A	N/A	Flare Slope RT (%)	N/A
N/A	Flare Traversable LT?	N/A	N/A	Flare Traversable RT?	N/A
N/A	Landing Length (in)	N/A	N/A	DWS Provided?	N/A
N/A	Landing Width (in)	N/A	N/A	DWS Contrast?	N/A
N/A	Landing Slope (%)	N/A	N/A	DWS Length (in)	N/A
N/A	Landing X Slope (%)	N/A	N/A	DWS Full Width?	N/A
N/A	Landing Curb? (Y/N)	N/A	N/A	DWS Offset (in)	N/A
N/A	Shared Landing?	N/A			
N/A	Gutter Ponding?	N/A	N/A	Gutter Slope (%)	N/A
N/A	Gutter Lip Ht (in)	N/A	N/A	Gutter X Slope (%)	N/A
N/A	Painted X Walk1?	No	N/A	Painted X Walk2?	N/A
	X Walk 1 Direction	To W		X Walk 2 Direction	N/A
N/A	X Walk 1 Width (in)	N/A	N/A	X Walk 2 Width (in)	N/A
	X Walk 1 Slope (%)	3.9		X Walk 2 Slope (%)	N/A
	X Walk 1 X Slope (%)	0.7		X Walk 2 X Slope (%)	N/A

N/A	Ramp inside XWalk1?	N/A	N/A	Ramp inside XWalk2?	N/A
	Road Slope (%)	N/A	N/A	Clear Space?	N/A
	Road X Slope (%)	N/A	N/A	Clear Space to XWalk (in)	N/A
N/A	Any Obstructions?	N/A	N/A	Storm Grate/Utility Hazard?	N/A
	Obstruction Type			Storm Grate/Utility Type	
		N/A			N/A
			Yes	Surface Condition? (G/P)	Good

Possible Solutions:

Remove & Replace Entire Ramp.
