Access Compliance Report

Public Rights-of-Way

(Curb Ramps)

Intersection ID: 16528	Main Street: E_PETERSON_DR	Cross Street: HERIOT_AV	Location: NW
ADA ID: 0F994570EC0A	Ramp Type: PerpDiag	Initial Pass/Fail: Fail	Overall Compliance: No
Severity Score: 10			
Codes/Mitigation Info/Possible Solution		Field Measurements/Component Compliance

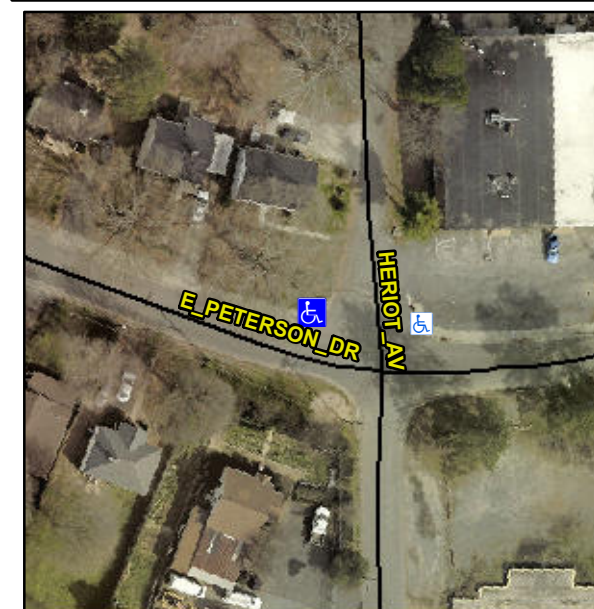
Not Found, R304.5.1, R304.5.3

Compliance	Description	Data	Compliance	Description	Data
N/A	Ramp Length (in)	71.0	Yes	Ramp Slope (%)	5.9
No	Ramp Width (in)	44.0	No	Ramp XSlope (%)	4.0
N/A	Flare Type LT	N/A	N/A	Flare Type RT	N/A
N/A	Flare Slope LT (%)	N/A	N/A	Flare Slope RT (%)	N/A
N/A	Flare Traversable LT?	N/A	N/A	Flare Traversable RT?	N/A
N/A	Landing Length (in)	N/A	N/A	DWS Provided?	N/A
N/A	Landing Width (in)	N/A	N/A	DWS Contrast?	N/A
N/A	Landing Slope (%)	N/A	N/A	DWS Length (in)	N/A
N/A	Landing X Slope (%)	N/A	N/A	DWS Full Width?	N/A
N/A	Landing Curb? (Y/N)	N/A	N/A	DWS Offset (in)	N/A
N/A	Shared Landing?	N/A			
N/A	Gutter Ponding?	N/A	N/A	Gutter Slope (%)	N/A
N/A	Gutter Lip Ht (in)	N/A	N/A	Gutter X Slope (%)	N/A
N/A	Painted X Walk1?	No	N/A	Painted X Walk2?	No
	X Walk 1 Direction	To S		X Walk 2 Direction	To E
N/A	X Walk 1 Width (in)	N/A	N/A	X Walk 2 Width (in)	N/A
	X Walk 1 Slope (%)	4.3		X Walk 2 Slope (%)	2.6
	X Walk 1 X Slope (%)	1.4		X Walk 2 X Slope (%)	4.6

N/A	Ramp inside XWalk1?	N/A	N/A	Ramp inside XWalk2?	N/A
	Road Slope (%)	3.3	N/A	Clear Space?	N/A
	Road X Slope (%)	3.1	N/A	Clear Space to XWalk (in)	N/A
N/A	Any Obstructions?	N/A	N/A	Storm Grate/Utility Hazard?	N/A
	Obstruction Type			Storm Grate/Utility Type	
		N/A			N/A
			Yes	Surface Condition? (G/P)	Good

Possible Solutions:

Remove & Replace Curb Ramp With Two New Directional Ramps or Equivalent.
