# Access Compliance Report

## Public Rights-of-Way

### (Curb Ramps)

| Intersection ID: 5654 | Main Street: JOHN_KIRK_DR | Cross Street: VAN_LANDINGHAM_RD | Location: SW |

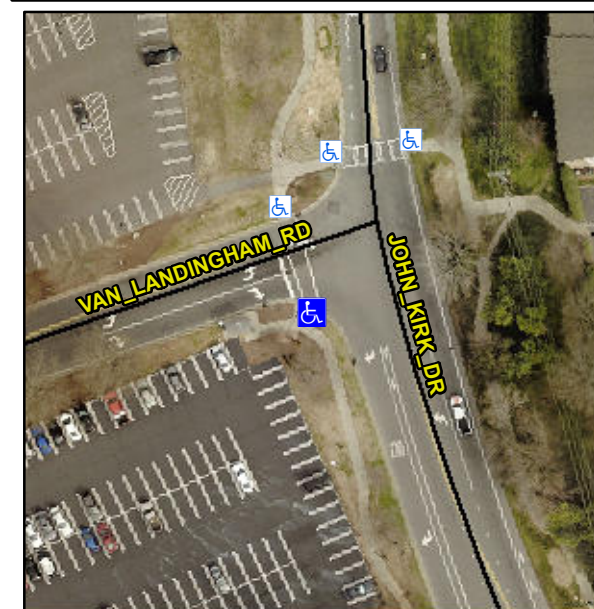
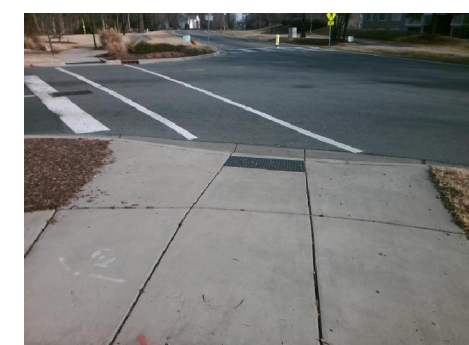
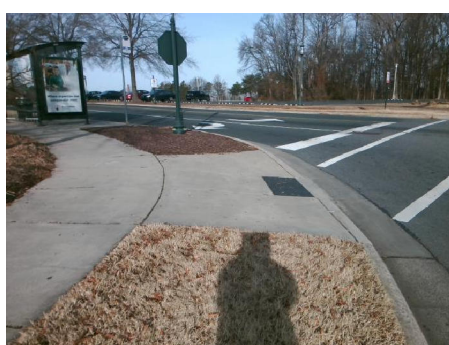
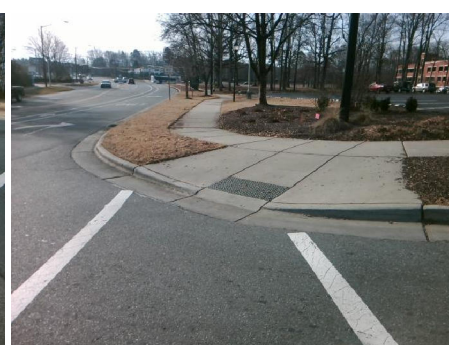
| ADA ID: 0FB21B16EAA3 | Ramp Type: Perp | Initial Pass/Fail: Fail | Overall Compliance: No |

**Not Found, R304.5.1, R304.2.2, R304.5.3**

| Compliance | Description | Data | Compliance | Description | Data |
|---|---|---|---|---|---|
| N/A | Ramp Length (in) | 91.0 | No | Ramp Slope (%) | 11.4 |
| No | Ramp Width (in) | 46.0 | No | Ramp XSlope (%) | 4.5 |

**Remove & Replace Entire Ramp.**
