## Access Compliance Report Public Rights-of-Way (Curb Ramps)

-	,						
Intersection ID: 29690	Main Street: CAMERON_CREEK_DR Cross				EQUESTRIAN_DR	Location:	NW			
ADA ID: 0FBCC033B111	I Ramp Ty	vpe: PerpDiag	Initial P	I Pass/Fail: Pass Overall Compliance: N				o Severity Score:	7.5	
Codes/Mitigation Info/Possible Solution					Field Measurements/Component Compliance					
		Possible Solutions:		Compliance Description			Data Compliance Description			
		Remove & Replace Curb Ramp W	lith	N/A	Ramp Length (in)	42.0	Yes	Ramp Slope (%)	5.9	
		Two New Directional Ramps or	-	Yes	Ramp Width (in)	49.5	Yes	Ramp XSlope (%)	0.7	
		Equivalent. Remove & Replace Gutter.		N/A	Flare Type LT	Sloped	N/A	Flare Type RT	N/A	
				N/A	Flare Slope LT (%)	3.5	Yes	Flare Slope RT (%)	3.9	
				N/A	Flare Traversable LT?	Yes	N/A	Flare Traversable RT?	Yes	
				No	Landing Length (in)	47.0	Yes	DWS Provided?	Yes	
				Yes	Landing Width (in)	59.5	Yes	DWS Contrast?	Yes	
EQUESTRIAN DR		N/A		No	Landing Slope (%)	2.2	Yes	DWS Length (in)	24.0

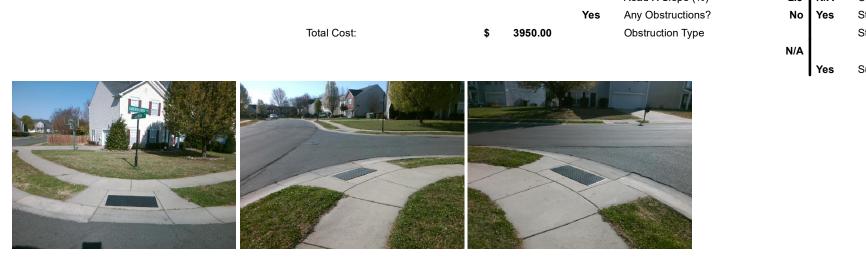
PROW/ADA:		Yes	Landing X Slope (%)	0.4	No	DWS Full Width?	No	
	6 H			N/A	Landing Curb? (Y/N)	No	No	DWS Offset (in)	4.0	
				N/A	Shared Landing?	No				
	us us			Yes	Gutter Ponding?	No	No	Gutter Slope (%)	14.5	
ALL AND A		R304.2.1, R304.2.2-Perp, R304.3.2	<u> </u>	Yes	Gutter Lip Ht (in)	0.0	Yes	Gutter X Slope (%)	1.4	
1 1 1 1 1	ALL ALLAND	Para, R305.1.4, R305.2, R304.5.4	.–	N/A	Painted X Walk1?	No	N/A	Painted X Walk2?	No	
	,,,,			X Walk 1 Direction	To S		X Walk 2 Direction	To E		
				N/A	X Walk 1 Width (in)	N/A	N/A	X Walk 2 Width (in)	N/A	
Street 1 Name	EQUESTRIAN DR	1			X Walk 1 Slope (%)	2.5		X Walk 2 Slope (%)	3.8	
Stop Condition-Street 2	StopSign				X Walk 1 X Slope (%)	2.2		X Walk 2 X Slope (%)	2.1	
Street 2 Name	CAMERON CREEK DR			N/A	Ramp inside XWalk1?	N/A	N/A	Ramp inside XWalk2?	N/A	
Stop Condition-Street 1	None				Road Slope (%)		N/A	Clear Space?	Yes	
					Road X Slope (%)	2.8	N/A	Clear Space to XWalk (in)	N/A

Yes	Any Obstructions?	No		Storm Grate/Utility Hazard?	No	
		Total Cost: \$39	50.00	100	Obstruction Type			Storm Grate/Utility Type		
		10121 0001. <b>V</b>				N/A		Storm Grate/Guilty Type	N/A	
						IN/A	1		11/74
