Access Compliance Report

Public Rights-of-Way

(Curb Ramps)

Intersection ID: 28345		Main Street: BACARDI_CT		Cross Street: HIRSCH_DR		Location:		NE	
ADA ID: 0FC1C13AB2CC		Ramp Type: Perp		Initial Pass/Fail: Fail		Overall Compliance: No		Severity Score: 30	
Codes/Mitigation Info/Possible Solution					Field Measurements/Component Compliance

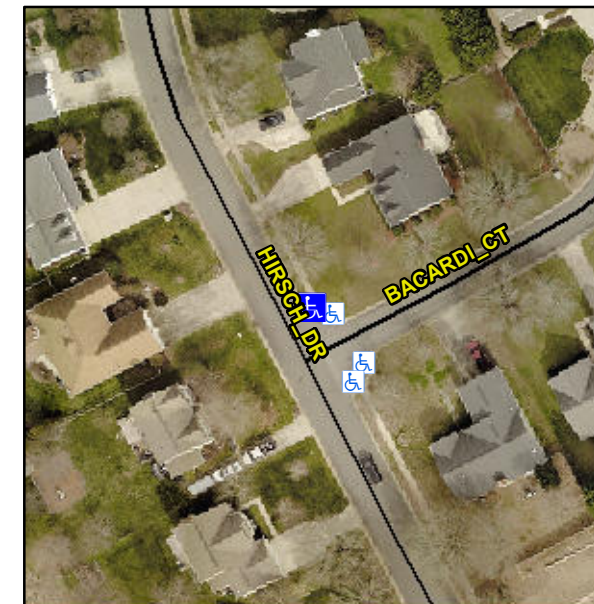
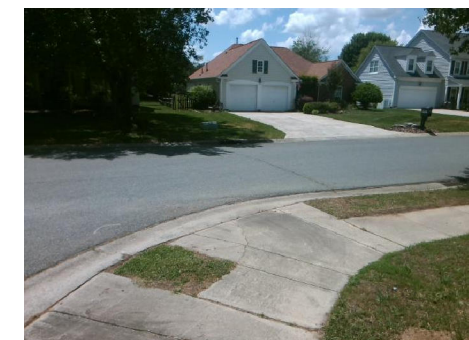
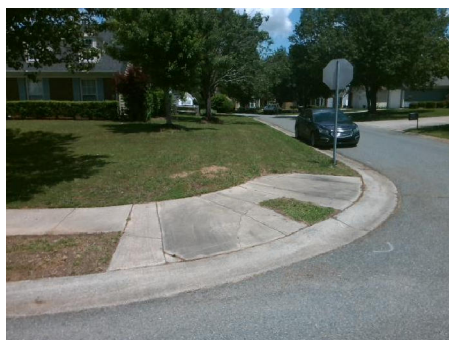
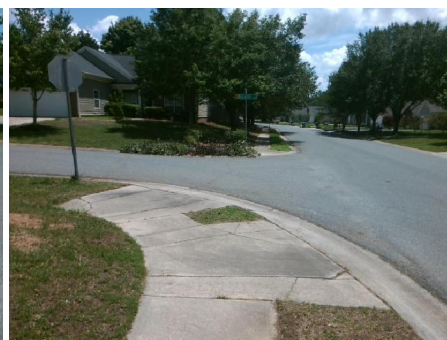
Not Found, R304.5.1, R304.2.2

Compliance	Description	Data	Compliance	Description	Data
N/A	Ramp Length (in)	93.0	No	Ramp Slope (%)	9.6
No	Ramp Width (in)	32.0	Yes	Ramp XSlope (%)	0.6
N/A	Flare Type LT	N/A	N/A	Flare Type RT	N/A
N/A	Flare Slope LT (%)	N/A	N/A	Flare Slope RT (%)	N/A
N/A	Flare Traversable LT?	N/A	N/A	Flare Traversable RT?	N/A
N/A	Landing Length (in)	N/A	N/A	DWS Provided?	N/A
N/A	Landing Width (in)	N/A	N/A	DWS Contrast?	N/A
N/A	Landing Slope (%)	N/A	N/A	DWS Length (in)	N/A
N/A	Landing X Slope (%)	N/A	N/A	DWS Full Width?	N/A
N/A	Landing Curb? (Y/N)	N/A	N/A	DWS Offset (in)	N/A
N/A	Shared Landing?	N/A			
N/A	Gutter Ponding?	N/A	N/A	Gutter Slope (%)	N/A
N/A	Gutter Lip Ht (in)	N/A	N/A	Gutter X Slope (%)	N/A
N/A	Painted X Walk1?	No	N/A	Painted X Walk2?	N/A
	X Walk 1 Direction	To SW		X Walk 2 Direction	N/A
N/A	X Walk 1 Width (in)	N/A	N/A	X Walk 2 Width (in)	N/A
	X Walk 1 Slope (%)	1.4		X Walk 2 Slope (%)	N/A
	X Walk 1 X Slope (%)	0.0		X Walk 2 X Slope (%)	N/A

N/A	Ramp inside XWalk1?	N/A	N/A	Ramp inside XWalk2?	N/A
	Road Slope (%)	N/A	N/A	Clear Space?	N/A
	Road X Slope (%)	N/A	N/A	Clear Space to XWalk (in)	N/A
N/A	Any Obstructions?	N/A	N/A	Storm Grate/Utility Hazard?	N/A
	Obstruction Type			Storm Grate/Utility Type	
		N/A			N/A
		Yes		Surface Condition? (G/P)	Good

Possible Solutions:

Remove & Replace Entire Ramp.
