Access Compliance Report

Public Rights-of-Way

(Curb Ramps)

Intersection ID: 3041	Main Street: BROWNE_RD	Cross Street: WHITE_STAG_DR	Location: W
ADA ID: 0FC5A727A279	Ramp Type: Perp	Initial Pass/Fail: Fail	Overall Compliance: No
Severity Score: 21.25			
Codes/Mitigation Info/Possible Solution		Field Measurements/Component Compliance

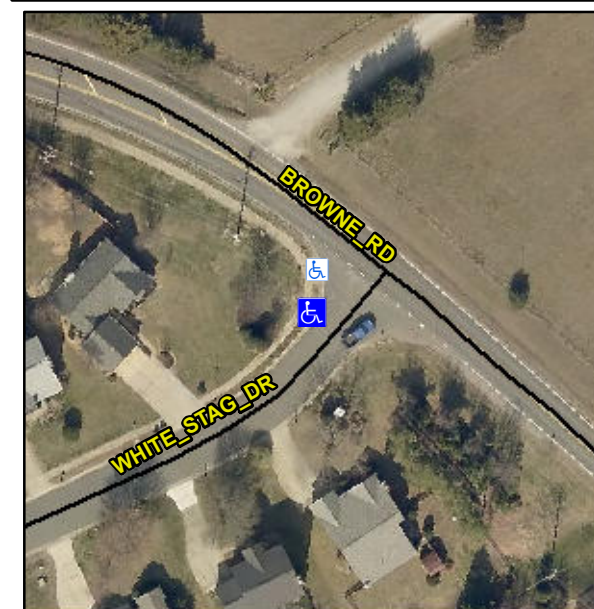
Compliance	Description	Data	Compliance	Description	Data
N/A	Ramp Length (in)	48.0	No	Ramp Slope (%)	10.5
No	Ramp Width (in)	44.0	Yes	Ramp XSlope (%)	1.7
N/A	Flare Type LT	N/A	N/A	Flare Type RT	N/A
N/A	Flare Slope LT (%)	N/A	N/A	Flare Slope RT (%)	N/A
N/A	Flare Traversable LT?	N/A	N/A	Flare Traversable RT?	N/A
N/A	Landing Length (in)	N/A	N/A	DWS Provided?	N/A
N/A	Landing Width (in)	N/A	N/A	DWS Contrast?	N/A
N/A	Landing Slope (%)	N/A	N/A	DWS Length (in)	N/A
N/A	Landing X Slope (%)	N/A	N/A	DWS Full Width?	N/A
N/A	Landing Curb? (Y/N)	N/A	N/A	DWS Offset (in)	N/A
N/A	Shared Landing?	N/A			
N/A	Gutter Ponding?	N/A	N/A	Gutter Slope (%)	N/A
N/A	Gutter Lip Ht (in)	N/A	N/A	Gutter X Slope (%)	N/A
N/A	Painted X Walk1?	No	N/A	Painted X Walk2?	N/A
	X Walk 1 Direction	To SE		X Walk 2 Direction	N/A
N/A	X Walk 1 Width (in)	N/A	N/A	X Walk 2 Width (in)	N/A
	X Walk 1 Slope (%)	0.6		X Walk 2 Slope (%)	N/A
	X Walk 1 X Slope (%)	1.6		X Walk 2 X Slope (%)	N/A

N/A	Ramp inside XWalk1?	N/A	N/A	Ramp inside XWalk2?	N/A
	Road Slope (%)	N/A	N/A	Clear Space?	N/A
	Road X Slope (%)	N/A	N/A	Clear Space to XWalk (in)	N/A
N/A	Any Obstructions?	N/A	N/A	Storm Grate/Utility Hazard?	N/A
	Obstruction Type			Storm Grate/Utility Type	
		N/A			N/A
		Yes		Surface Condition? (G/P)	Good

Remove & Replace Entire Ramp.

R304.5.1, R304.2.2

\$ 1850.00
