# Access Compliance Report

## Public Rights-of-Way

### (Curb Ramps)

Intersection ID: 2739	Main Street: BELL'S_MILL_DR	Cross Street: WINGMONT_DR	Location: SE
ADA ID: 0FC8F5ABD513	Ramp Type: PerpDiag	Initial Pass/Fail: Fail	Overall Compliance: No
		Severity Score: 12.5

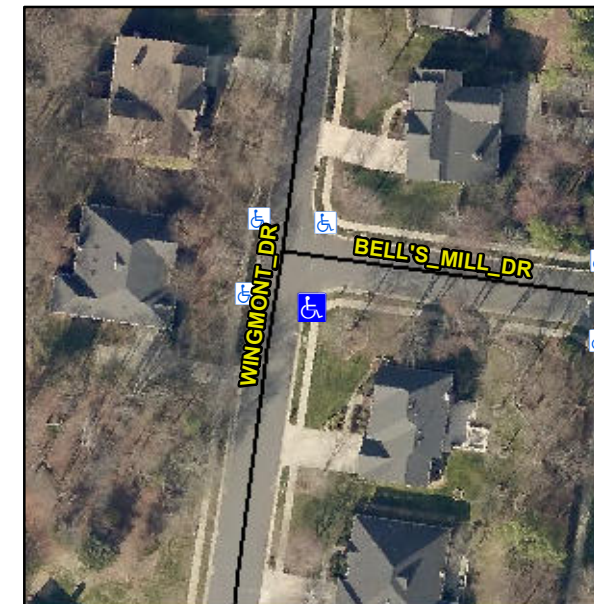
**Not Found, R304.2.2**

Compliance	Description	Data	Compliance	Description	Data
N/A	Ramp Length (in)	47.0	No	Ramp Slope (%)	10.6
Yes	Ramp Width (in)	53.5	Yes	Ramp XSlope (%)	1.4
N/A	Flare Type LT	N/A	N/A	Flare Type RT	N/A
N/A	Flare Slope LT (%)	N/A	N/A	Flare Slope RT (%)	N/A
N/A	Flare Traversable LT?	N/A	N/A	Flare Traversable RT?	N/A
N/A	Landing Length (in)	N/A	N/A	DWS Provided?	N/A
N/A	Landing Width (in)	N/A	N/A	DWS Contrast?	N/A
N/A	Landing Slope (%)	N/A	N/A	DWS Length (in)	N/A
N/A	Landing X Slope (%)	N/A	N/A	DWS Full Width?	N/A
N/A	Landing Curb? (Y/N)	N/A	N/A	DWS Offset (in)	N/A
N/A	Shared Landing?	N/A			
N/A	Gutter Ponding?	N/A	N/A	Gutter Slope (%)	N/A
N/A	Gutter Lip Ht (in)	N/A	N/A	Gutter X Slope (%)	N/A
N/A	Painted X Walk1?	No	N/A	Painted X Walk2?	No
	X Walk 1 Direction	To N		X Walk 2 Direction	To W
N/A	X Walk 1 Width (in)	N/A	N/A	X Walk 2 Width (in)	N/A
	X Walk 1 Slope (%)	0.9		X Walk 2 Slope (%)	2.8
	X Walk 1 X Slope (%)	1.1		X Walk 2 X Slope (%)	0.9

N/A	Ramp inside XWalk1?	N/A	N/A	Ramp inside XWalk2?	N/A
	Road Slope (%)	0.9	N/A	Clear Space?	N/A
	Road X Slope (%)	4.3	N/A	Clear Space to XWalk (in)	N/A
N/A	Any Obstructions?	N/A	N/A	Storm Grate/Utility Hazard?	N/A
	Obstruction Type			Storm Grate/Utility Type	
		N/A			N/A
			Yes	Surface Condition? (G/P)	Good

**Remove & Replace Curb Ramp With Two New Directional Ramps or Equivalent.**

Total Cost: \$ 3200.00
