Access Compliance Report

Public Rights-of-Way

(Curb Ramps)

Intersection ID: 43850	Main Street: BRADSTREET COMMONS WY	Cross Street: HAMEL ST	Location: S
ADA ID: 0FD8289A3F25	Ramp Type: PerpDiag	Initial Pass/Fail: Fail	Overall Compliance: No
Severity Score: 25			
Codes/Mitigation Info/Possible Solution		Field Measurements/Component Compliance

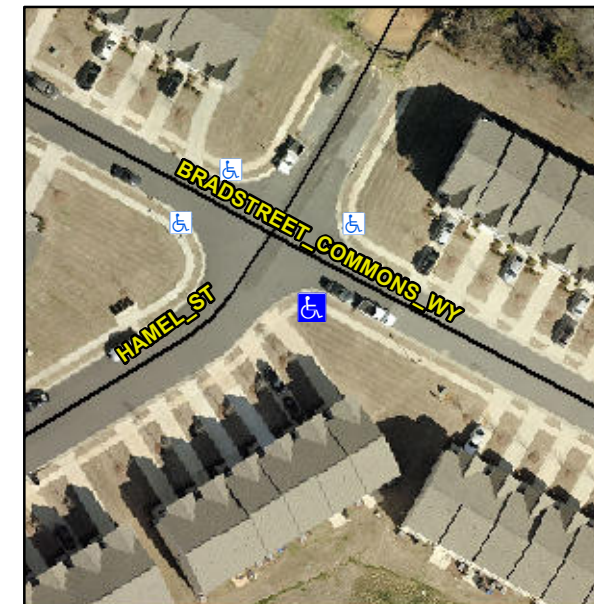
Not Found, R304.2.2, R304.5.3

Compliance	Description	Data	Compliance	Description	Data
N/A	Ramp Length (in)	46.5	No	Ramp Slope (%)	10.0
Yes	Ramp Width (in)	48.0	No	Ramp XSlope (%)	5.3
N/A	Flare Type LT	N/A	N/A	Flare Type RT	N/A
N/A	Flare Slope LT (%)	N/A	N/A	Flare Slope RT (%)	N/A
N/A	Flare Traversable LT?	N/A	N/A	Flare Traversable RT?	N/A
N/A	Landing Length (in)	N/A	N/A	DWS Provided?	N/A
N/A	Landing Width (in)	N/A	N/A	DWS Contrast?	N/A
N/A	Landing Slope (%)	N/A	N/A	DWS Length (in)	N/A
N/A	Landing X Slope (%)	N/A	N/A	DWS Full Width?	N/A
N/A	Landing Curb? (Y/N)	N/A	N/A	DWS Offset (in)	N/A
N/A	Shared Landing?	N/A			
N/A	Gutter Ponding?	N/A	N/A	Gutter Slope (%)	N/A
N/A	Gutter Lip Ht (in)	N/A	N/A	Gutter X Slope (%)	N/A
N/A	Painted X Walk1?	No	N/A	Painted X Walk2?	No
	X Walk 1 Direction	To NE		X Walk 2 Direction	To NW
N/A	X Walk 1 Width (in)	N/A	N/A	X Walk 2 Width (in)	N/A
	X Walk 1 Slope (%)	4.4		X Walk 2 Slope (%)	1.9
	X Walk 1 X Slope (%)	4.0		X Walk 2 X Slope (%)	2.8

N/A	Ramp inside XWalk1?	N/A	N/A	Ramp inside XWalk2?	N/A
	Road Slope (%)	4.6	N/A	Clear Space?	N/A
	Road X Slope (%)	2.2	N/A	Clear Space to XWalk (in)	N/A
N/A	Any Obstructions?	N/A	N/A	Storm Grate/Utility Hazard?	N/A
	Obstruction Type			Storm Grate/Utility Type	
		N/A			N/A
			Yes	Surface Condition? (G/P)	Good

Remove & Replace Curb Ramp With Two New Directional Ramps or Equivalent.
