Access Compliance Report

Public Rights-of-Way

(Curb Ramps)

Intersection ID: 5565	Main Street: COLIN_CREEK_LN	Cross Street: SPARKLING_BROOK_CT	Location:	N
ADA ID: 0FDF25D4BF89	Ramp Type: Perp	Initial Pass/Fail: Fail	Overall Compliance: No	Severity Score: 1.25

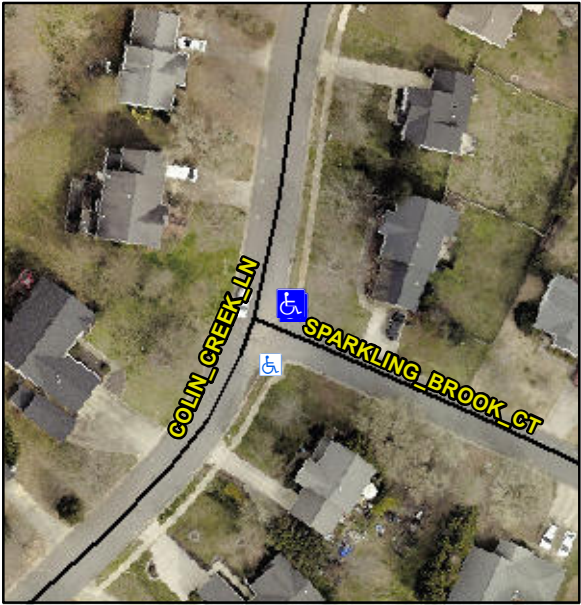
Possible Solutions:		Compliance	Description	Data
	Remove & Replace Entire Ramp.		N/A	Ramp Length (in)	49.0
			Yes	Ramp Width (in)	48.0
			N/A	Flare Type LT	N/A
			N/A	Flare Slope LT (%)	N/A
			N/A	Flare Traversable LT?	N/A
			N/A	Landing Length (in)	N/A
			N/A	Landing Width (in)	N/A
			N/A	Landing Slope (%)	N/A
			N/A	Landing X Slope (%)	N/A
<p>Surveyor Notes:</p> <p>N/A</p> <p>PROW/ADA:</p> <p>Not Found, R304.5.3</p>			N/A	Flare Type RT	N/A
			N/A	Flare Slope RT (%)	N/A
			N/A	Flare Traversable RT?	N/A
			N/A	DWS Provided?	N/A
			N/A	DWS Contrast?	N/A
			N/A	DWS Length (in)	N/A
			N/A	DWS Full Width?	N/A
			N/A	DWS Offset (in)	N/A
			N/A	Shared Landing?	N/A
			N/A	Gutter Ponding?	N/A
			N/A	Gutter Lip Ht (in)	N/A
			N/A	Painted X Walk1?	No
				X Walk 1 Direction	To S
			N/A	X Walk 1 Width (in)	N/A
				X Walk 1 Slope (%)	1.9
				X Walk 1 X Slope (%)	2.4

N/A	Ramp inside XWalk1?	N/A
			N/A	Road Slope (%)	N/A
			N/A	Road X Slope (%)	N/A
			N/A	Any Obstructions?	N/A
				Obstruction Type	
Total Cost:		\$ 1850.00			
			N/A		N/A
			Yes	Surface Condition? (G/P)	Good
