Access Compliance Report

Public Rights-of-Way

(Curb Ramps)

Intersection ID: 10749	Main Street: ALLEGHANY_ST	Cross Street: FREEDOM_DR	Location: S
ADA ID: 0FE68D3055A8	Ramp Type: Perp	Initial Pass/Fail: Fail	Overall Compliance: No
Severity Score: 8.75			
Codes/Mitigation Info/Possible Solution		Field Measurements/Component Compliance

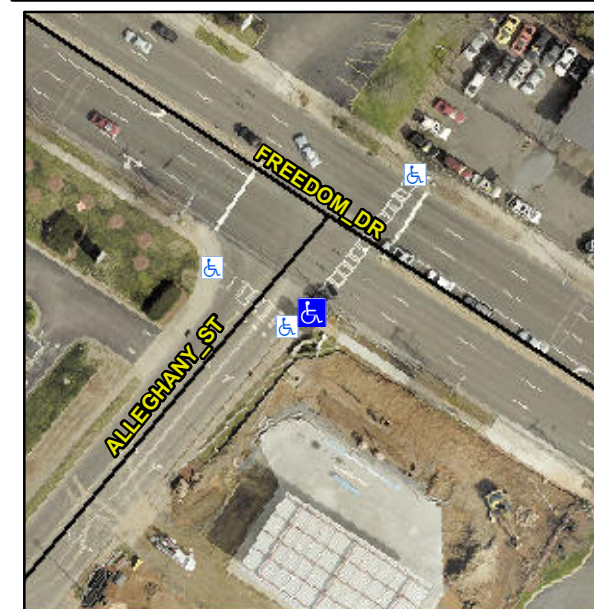
Not Found, R304.5.1

Compliance	Description	Data	Compliance	Description	Data
N/A	Ramp Length (in)	90.0	Yes	Ramp Slope (%)	5.0
No	Ramp Width (in)	47.5	Yes	Ramp XSlope (%)	2.0
N/A	Flare Type LT	N/A	N/A	Flare Type RT	N/A
N/A	Flare Slope LT (%)	N/A	N/A	Flare Slope RT (%)	N/A
N/A	Flare Traversable LT?	N/A	N/A	Flare Traversable RT?	N/A
N/A	Landing Length (in)	N/A	N/A	DWS Provided?	N/A
N/A	Landing Width (in)	N/A	N/A	DWS Contrast?	N/A
N/A	Landing Slope (%)	N/A	N/A	DWS Length (in)	N/A
N/A	Landing X Slope (%)	N/A	N/A	DWS Full Width?	N/A
N/A	Landing Curb? (Y/N)	N/A	N/A	DWS Offset (in)	N/A
N/A	Shared Landing?	N/A			
N/A	Gutter Ponding?	N/A	N/A	Gutter Slope (%)	N/A
N/A	Gutter Lip Ht (in)	N/A	N/A	Gutter X Slope (%)	N/A
N/A	Painted X Walk1?	Yes	N/A	Painted X Walk2?	N/A
	X Walk 1 Direction	To NE		X Walk 2 Direction	N/A
N/A	X Walk 1 Width (in)	69.0	N/A	X Walk 2 Width (in)	N/A
	X Walk 1 Slope (%)	2.1		X Walk 2 Slope (%)	N/A
	X Walk 1 X Slope (%)	2.9		X Walk 2 X Slope (%)	N/A

N/A	Ramp inside XWalk1?	Yes	N/A	Ramp inside XWalk2?	N/A
	Road Slope (%)	N/A	N/A	Clear Space?	N/A
	Road X Slope (%)	N/A	N/A	Clear Space to XWalk (in)	N/A
N/A	Any Obstructions?	N/A	N/A	Storm Grate/Utility Hazard?	N/A
	Obstruction Type			Storm Grate/Utility Type	
		N/A			N/A
		Yes		Surface Condition? (G/P)	Good

Possible Solutions:

Remove & Replace Entire Ramp.

Total Cost: \$ 1850.00
