Access Compliance Report

Public Rights-of-Way

(Curb Ramps)

Intersection ID: 16506	Main Street: ELLINGTON_ST	Cross Street: N_WENDOVER_RD	Location: NW
ADA ID: 0FE7D4566E23	Ramp Type: PerpDiag	Initial Pass/Fail: Fail	Overall Compliance: No
		Severity Score: 12.5

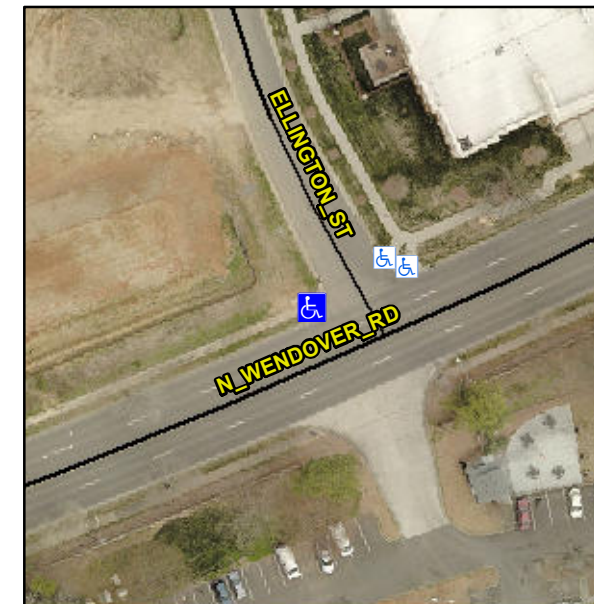
Not Found, R304.5.3

Compliance	Description	Data	Compliance	Description	Data
N/A	Ramp Length (in)	67.0	Yes	Ramp Slope (%)	5.7
Yes	Ramp Width (in)	48.0	No	Ramp XSlope (%)	6.9
N/A	Flare Type LT	N/A	N/A	Flare Type RT	N/A
N/A	Flare Slope LT (%)	N/A	N/A	Flare Slope RT (%)	N/A
N/A	Flare Traversable LT?	N/A	N/A	Flare Traversable RT?	N/A
N/A	Landing Length (in)	N/A	N/A	DWS Provided?	N/A
N/A	Landing Width (in)	N/A	N/A	DWS Contrast?	N/A
N/A	Landing Slope (%)	N/A	N/A	DWS Length (in)	N/A
N/A	Landing X Slope (%)	N/A	N/A	DWS Full Width?	N/A
N/A	Landing Curb? (Y/N)	N/A	N/A	DWS Offset (in)	N/A
N/A	Shared Landing?	N/A			
N/A	Gutter Ponding?	N/A	N/A	Gutter Slope (%)	N/A
N/A	Gutter Lip Ht (in)	N/A	N/A	Gutter X Slope (%)	N/A
N/A	Painted X Walk1?	No	N/A	Painted X Walk2?	No
	X Walk 1 Direction	To SE		X Walk 2 Direction	To NE
N/A	X Walk 1 Width (in)	N/A	N/A	X Walk 2 Width (in)	N/A
	X Walk 1 Slope (%)	1.7		X Walk 2 Slope (%)	5.4
	X Walk 1 X Slope (%)	3.0		X Walk 2 X Slope (%)	4.7

N/A	Ramp inside XWalk1?	N/A	N/A	Ramp inside XWalk2?	N/A
	Road Slope (%)	5.2	N/A	Clear Space?	N/A
	Road X Slope (%)	0.5	N/A	Clear Space to XWalk (in)	N/A
N/A	Any Obstructions?	N/A	N/A	Storm Grate/Utility Hazard?	N/A
	Obstruction Type			Storm Grate/Utility Type	
		N/A			N/A
		Yes		Surface Condition? (G/P)	Good

Remove & Replace Curb Ramp With Two New Directional Ramps or Equivalent.
