# Access Compliance Report

## Public Rights-of-Way

### (Curb Ramps)

Intersection ID: 11270	Main Street: ALANBROOK_RD	Cross Street: SIR_BARTON_CT	Location: NW
ADA ID: 0FE82F4978CF	Ramp Type: Perp	Initial Pass/Fail: Fail	Overall Compliance: No
		Severity Score: 8.75

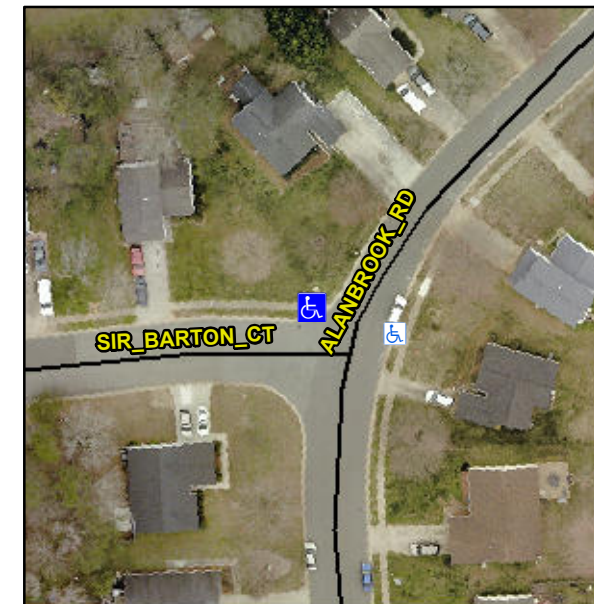
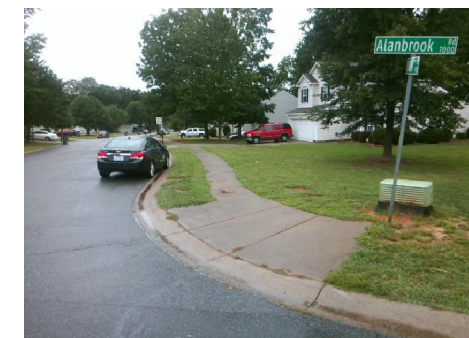
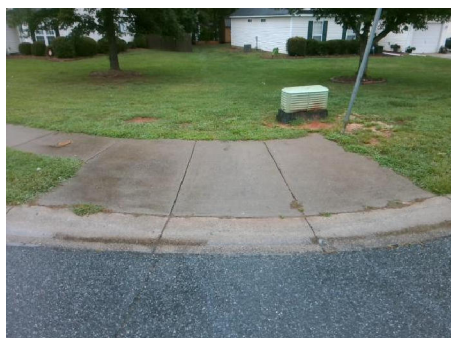
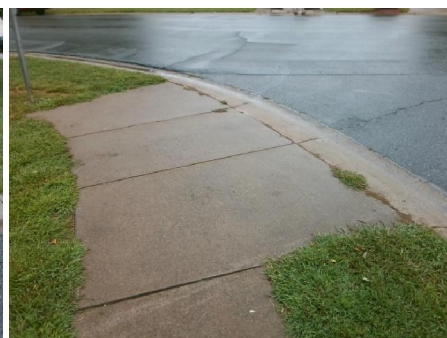
**Not Found, R304.5.1**

Compliance	Description	Data	Compliance	Description	Data
N/A	Ramp Length (in)	93.0	Yes	Ramp Slope (%)	5.2
No	Ramp Width (in)	44.5	Yes	Ramp XSlope (%)	1.3
N/A	Flare Type LT	N/A	N/A	Flare Type RT	N/A
N/A	Flare Slope LT (%)	N/A	N/A	Flare Slope RT (%)	N/A
N/A	Flare Traversable LT?	N/A	N/A	Flare Traversable RT?	N/A
N/A	Landing Length (in)	N/A	N/A	DWS Provided?	N/A
N/A	Landing Width (in)	N/A	N/A	DWS Contrast?	N/A
N/A	Landing Slope (%)	N/A	N/A	DWS Length (in)	N/A
N/A	Landing X Slope (%)	N/A	N/A	DWS Full Width?	N/A
N/A	Landing Curb? (Y/N)	N/A	N/A	DWS Offset (in)	N/A
N/A	Shared Landing?	N/A			
N/A	Gutter Ponding?	N/A	N/A	Gutter Slope (%)	N/A
N/A	Gutter Lip Ht (in)	N/A	N/A	Gutter X Slope (%)	N/A
N/A	Painted X Walk1?	No	N/A	Painted X Walk2?	N/A
	X Walk 1 Direction	To E		X Walk 2 Direction	N/A
N/A	X Walk 1 Width (in)	N/A	N/A	X Walk 2 Width (in)	N/A
	X Walk 1 Slope (%)	6.3		X Walk 2 Slope (%)	N/A
	X Walk 1 X Slope (%)	1.6		X Walk 2 X Slope (%)	N/A

N/A	Ramp inside XWalk1?	N/A	N/A	Ramp inside XWalk2?	N/A
	Road Slope (%)	N/A	N/A	Clear Space?	N/A
	Road X Slope (%)	N/A	N/A	Clear Space to XWalk (in)	N/A
N/A	Any Obstructions?	N/A	N/A	Storm Grate/Utility Hazard?	N/A
	Obstruction Type			Storm Grate/Utility Type	
		N/A			N/A
			Yes	Surface Condition? (G/P)	Good

**Remove & Replace Entire Ramp.**

Total Cost: \$ 1850.00
