Access Compliance Report

Public Rights-of-Way (Curb Ramps)

Intersection ID: 51011	Main Street: TREMONT_PLACE_RD	Cross Street: BENDING_BRANCH_RD	Location: NW
ADA ID: 0FEDABFA352B	Ramp Type: Perp	Initial Pass/Fail: Fail	Overall Compliance: No
Severity Score: 22.5			
Codes/Mitigation Info/Possible Solution		Field Measurements/Component Compliance

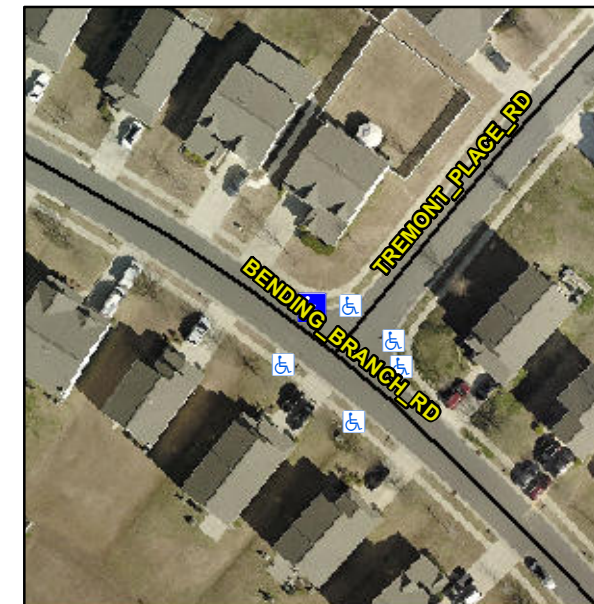
Not Found, R304.5.1, R304.2.2, R304.5.3

Compliance	Description	Data	Compliance	Description	Data
N/A	Ramp Length (in)	47.0	No	Ramp Slope (%)	11.1
No	Ramp Width (in)	47.5	No	Ramp XSlope (%)	4.0
N/A	Flare Type LT	N/A	N/A	Flare Type RT	N/A
N/A	Flare Slope LT (%)	N/A	N/A	Flare Slope RT (%)	N/A
N/A	Flare Traversable LT?	N/A	N/A	Flare Traversable RT?	N/A
N/A	Landing Length (in)	N/A	N/A	DWS Provided?	N/A
N/A	Landing Width (in)	N/A	N/A	DWS Contrast?	N/A
N/A	Landing Slope (%)	N/A	N/A	DWS Length (in)	N/A
N/A	Landing X Slope (%)	N/A	N/A	DWS Full Width?	N/A
N/A	Landing Curb? (Y/N)	N/A	N/A	DWS Offset (in)	N/A
N/A	Shared Landing?	N/A			
N/A	Gutter Ponding?	N/A	N/A	Gutter Slope (%)	N/A
N/A	Gutter Lip Ht (in)	N/A	N/A	Gutter X Slope (%)	N/A
N/A	Painted X Walk1?	No	N/A	Painted X Walk2?	N/A
	X Walk 1 Direction	To S		X Walk 2 Direction	N/A
N/A	X Walk 1 Width (in)	N/A	N/A	X Walk 2 Width (in)	N/A
	X Walk 1 Slope (%)	3.0		X Walk 2 Slope (%)	N/A
	X Walk 1 X Slope (%)	2.2		X Walk 2 X Slope (%)	N/A

N/A	Ramp inside XWalk1?	N/A	N/A	Ramp inside XWalk2?	N/A
	Road Slope (%)	N/A	N/A	Clear Space?	N/A
	Road X Slope (%)	N/A	N/A	Clear Space to XWalk (in)	N/A
N/A	Any Obstructions?	N/A	N/A	Storm Grate/Utility Hazard?	N/A
	Obstruction Type			Storm Grate/Utility Type	
		N/A			N/A
			Yes	Surface Condition? (G/P)	Good

Possible Solutions:

Remove & Replace Entire Ramp.
