Access Compliance Report

Public Rights-of-Way

(Curb Ramps)

Intersection ID: 4677	Main Street: OLD_STATESVILLE_RD	Cross Street: HENDERSON_RD	Location: W
ADA ID: 0FEECEB7A7B3	Ramp Type: Perp	Initial Pass/Fail: Fail	Overall Compliance: No
		Severity Score: 12.5

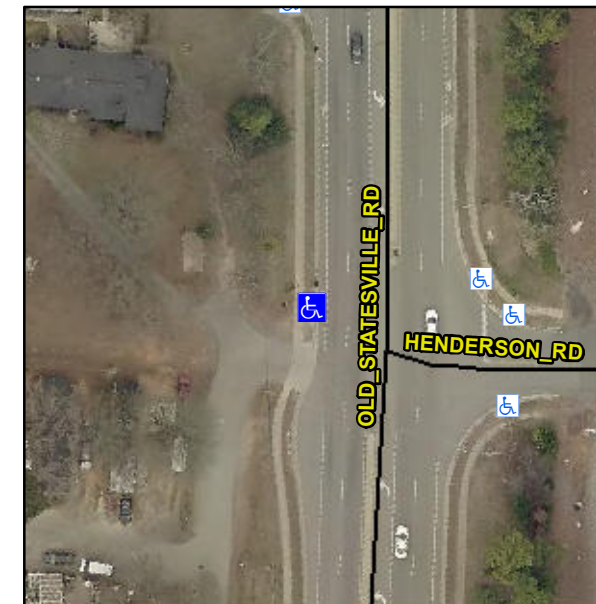
Not Found, R304.2.2

Compliance	Description	Data	Compliance	Description	Data
N/A	Ramp Length (in)	60.0	No	Ramp Slope (%)	10.5
Yes	Ramp Width (in)	48.0	Yes	Ramp XSlope (%)	1.1
N/A	Flare Type LT	N/A	N/A	Flare Type RT	N/A
N/A	Flare Slope LT (%)	N/A	N/A	Flare Slope RT (%)	N/A
N/A	Flare Traversable LT?	N/A	N/A	Flare Traversable RT?	N/A
N/A	Landing Length (in)	N/A	N/A	DWS Provided?	N/A
N/A	Landing Width (in)	N/A	N/A	DWS Contrast?	N/A
N/A	Landing Slope (%)	N/A	N/A	DWS Length (in)	N/A
N/A	Landing X Slope (%)	N/A	N/A	DWS Full Width?	N/A
N/A	Landing Curb? (Y/N)	N/A	N/A	DWS Offset (in)	N/A
N/A	Shared Landing?	N/A			
N/A	Gutter Ponding?	N/A	N/A	Gutter Slope (%)	N/A
N/A	Gutter Lip Ht (in)	N/A	N/A	Gutter X Slope (%)	N/A
N/A	Painted X Walk1?	No	N/A	Painted X Walk2?	N/A
	X Walk 1 Direction	To E		X Walk 2 Direction	N/A
N/A	X Walk 1 Width (in)	N/A	N/A	X Walk 2 Width (in)	N/A
	X Walk 1 Slope (%)	2.2		X Walk 2 Slope (%)	N/A
	X Walk 1 X Slope (%)	1.5		X Walk 2 X Slope (%)	N/A

Possible Solutions:

Remove & Replace Entire Ramp.

Total Cost: \$ 1850.00
