# Access Compliance Report

## Public Rights-of-Way

### (Curb Ramps)

Intersection ID: 12076	Main Street: N_CHURCH_ST	Cross Street: W_5TH_ST	Location: E
ADA ID: 0FF78B3BF0A7	Ramp Type: BlendTrans1	Initial Pass/Fail: Fail	Overall Compliance: No
			Severity Score: 21.25

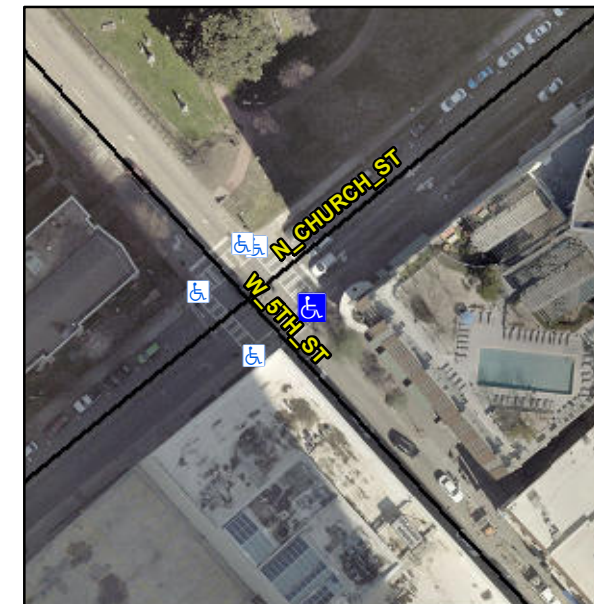
Compliance	Description	Data	Compliance	Description	Data
N/A	Ramp Length (in)	24.0	Yes	BlendTrans Slope (%)	4.3
No	Ramp Width (in)	46.5	No	BlendTrans XSlope (%)	6.0
N/A	Flare Type LT	N/A	N/A	Flare Type RT	N/A
N/A	Flare Slope LT (%)	N/A	N/A	Flare Slope RT (%)	N/A
N/A	Flare Traversable LT?	N/A	N/A	Flare Traversable RT?	N/A
N/A	Landing Length (in)	N/A	N/A	DWS Provided?	N/A
N/A	Landing Width (in)	N/A	N/A	DWS Contrast?	N/A
N/A	Landing Slope (%)	N/A	N/A	DWS Length (in)	N/A
N/A	Landing X Slope (%)	N/A	N/A	DWS Full Width?	N/A
N/A	Landing Curb? (Y/N)	N/A	N/A	DWS Offset (in)	N/A
N/A	Shared Landing?	N/A			
N/A	Gutter Ponding?	N/A	N/A	Gutter Slope (%)	N/A
N/A	Gutter Lip Ht (in)	N/A	N/A	Gutter X Slope (%)	N/A
N/A	Painted X Walk1?	Yes	N/A	Painted X Walk2?	Yes
	X Walk 1 Direction	To NW		X Walk 2 Direction	To SW
	X Walk 1 Width (in)	110.0		X Walk 2 Width (in)	110.0
	X Walk 1 Slope (%)	4.4		X Walk 2 Slope (%)	7.8
	X Walk 1 X Slope (%)	6.5		X Walk 2 X Slope (%)	1.4

N/A	Ramp inside XWalk1?	Yes	N/A	Ramp inside XWalk2?	Yes
	Road Slope (%)	7.0		Clear Space?	N/A
	Road X Slope (%)	3.3	N/A	Clear Space to XWalk (in)	N/A
N/A	Any Obstructions?	N/A	N/A	Storm Grate/Utility Hazard?	N/A
	Obstruction Type			Storm Grate/Utility Type	
		N/A			N/A
			Yes	Surface Condition? (G/P)	Good
			N/A	Curb Slope (%)	2.9

**Remove & Replace Curb Ramp With Two New Directional Ramps or Equivalent.**

**R304.5.1, R304.5.3**
