Intersection ID: 43131	Main Street: DR_WEBBER_AV	Cross Street: BEATTIES_FORD_RD	Location:	NE
ADA ID: 0FF8C1F62DEF	Ramp Type: Perp	Initial Pass/Fail: Fail	Overall Compliance: No	Severity Score: 8.75

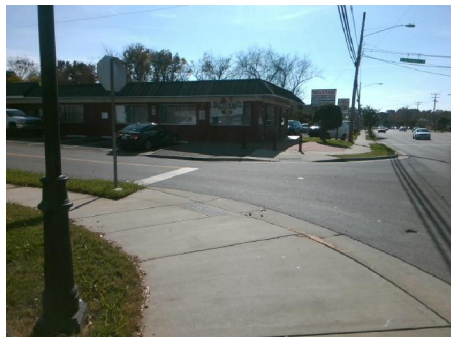
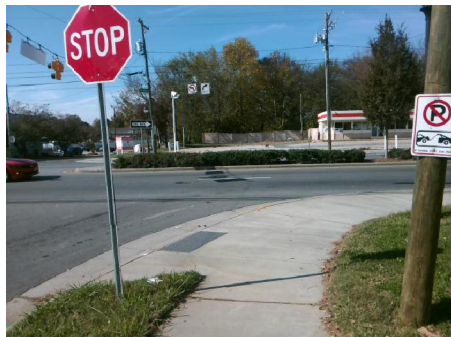
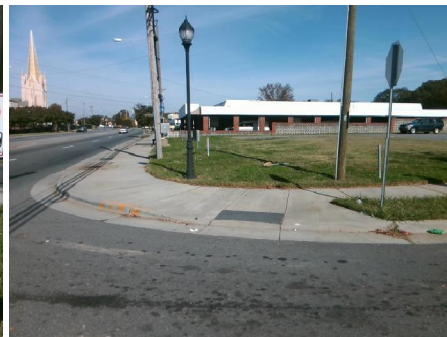
Compliance	Description	Data	Compliance	Description	Data
N/A	Ramp Length (in)	115.5	Yes	Ramp Slope (%)	5.4
No	Ramp Width (in)	40.0	Yes	Ramp XSlope (%)	1.1
N/A	Flare Type LT	N/A	N/A	Flare Type RT	N/A
N/A	Flare Slope LT (%)	N/A	N/A	Flare Slope RT (%)	N/A
N/A	Flare Traversable LT?	N/A	N/A	Flare Traversable RT?	N/A
N/A	Landing Length (in)	N/A	N/A	DWS Provided?	N/A
N/A	Landing Width (in)	N/A	N/A	DWS Contrast?	N/A
N/A	Landing Slope (%)	N/A	N/A	DWS Length (in)	N/A
N/A	Landing X Slope (%)	N/A	N/A	DWS Full Width?	N/A
N/A	Landing Curb? (Y/N)	N/A	N/A	DWS Offset (in)	N/A
N/A	Shared Landing?	N/A			
N/A	Gutter Ponding?	N/A	N/A	Gutter Slope (%)	N/A
N/A	Gutter Lip Ht (in)	N/A	N/A	Gutter X Slope (%)	N/A
N/A	Painted X Walk1?	No	N/A	Painted X Walk2?	N/A
	X Walk 1 Direction	To S		X Walk 2 Direction	N/A
N/A	X Walk 1 Width (in)	N/A	N/A	X Walk 2 Width (in)	N/A
	X Walk 1 Slope (%)	1.0		X Walk 2 Slope (%)	N/A
	X Walk 1 X Slope (%)	0.9		X Walk 2 X Slope (%)	N/A

N/A	Ramp inside XWalk1?	N/A	N/A	Ramp inside XWalk2?	N/A
	Road Slope (%)	N/A	N/A	Clear Space?	N/A
	Road X Slope (%)	N/A	N/A	Clear Space to XWalk (in)	N/A
N/A	Any Obstructions?	N/A	N/A	Storm Grate/Utility Hazard?	N/A
	Obstruction Type			Storm Grate/Utility Type	
		N/A			N/A
			Yes	Surface Condition? (G/P)	Good

Possible Solutions:

Remove & Replace Entire Ramp.

Not Found, R304.5.1
