## Access Compliance Report Public Rights-of-Way (Curb Ramps)

Intersection ID: 3999 Main Street: CULLINGFORD\_LN Cross Street: AMBLESIDE\_DR Location: NE

ADA ID: 1002AEC78C1F Ramp Type: BlendTrans2 Initial Pass/Fail: Fail Overall Compliance: No Severity Score: 60

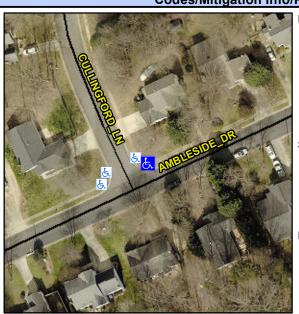
Not Found, R304.5.1, R304.5.3

Compliance Description Data Compliance Description Data Yes N/A Ramp Length (in) 94.0 BlendTrans Slope (%) 4.4 No No Ramp Width (in) 24.0 BlendTrans XSlope (%) 7.4 N/A N/A Flare Type LT N/A Flare Type RT N/A N/A Flare Slope LT (%) N/A N/A Flare Slope RT (%) N/A N/A Flare Traversable LT? N/A N/A Flare Traversable RT? N/A N/A Landing Length (in) N/A N/A DWS Provided? N/A N/A Landing Width (in) N/A N/A **DWS Contrast?** N/A N/A N/A N/A Landing Slope (%) DWS Length (in) N/A N/A Landing X Slope (%) N/A N/A DWS Full Width? N/A N/A Landing Curb? (Y/N) N/A N/A DWS Offset (in) N/A N/A N/A Shared Landing? N/A **Gutter Ponding?** N/A N/A Gutter Slope (%) N/A N/A Gutter Lip Ht (in) N/A N/A Gutter X Slope (%) N/A N/A Painted X Walk1? No N/A Painted X Walk2? N/A X Walk 1 Direction To S X Walk 2 Direction N/A N/A X Walk 1 Width (in) X Walk 2 Width (in) N/A X Walk 1 Slope (%) 4.5 X Walk 2 Slope (%) N/A X Walk 1 X Slope (%) 0.3 X Walk 2 X Slope (%) N/A N/A N/A Ramp inside XWalk2? N/A N/A Ramp inside XWalk1? Road Slope (%) 0.3 Clear Space? N/A N/A Road X Slope (%) Clear Space to XWalk (in) N/A 4.5 N/A N/A N/A Any Obstructions? Storm Grate/Utility Hazard? N/A **Obstruction Type** Storm Grate/Utility Type N/A N/A Yes Surface Condition? (G/P) Good No 10.2 Curb Slope (%)

Remove & Replace Curb Ramp With Two New Directional Ramps or Equivalent.
