Access Compliance Report

Public Rights-of-Way

(Curb Ramps)

Intersection ID: 19888	Main Street: SHIRAS_CT	Cross Street: THORNFIELD_RD	Location: SW
ADA ID: 1004884916D8	Ramp Type: BlendTrans2	Initial Pass/Fail: Fail	Overall Compliance: No
		Severity Score: 12.5

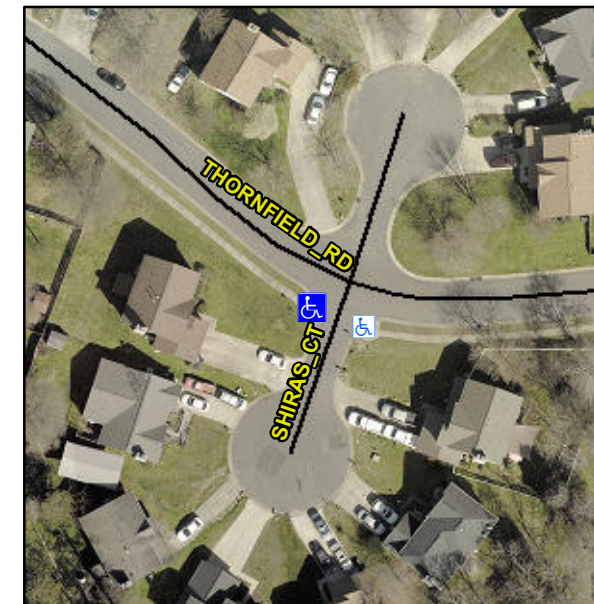
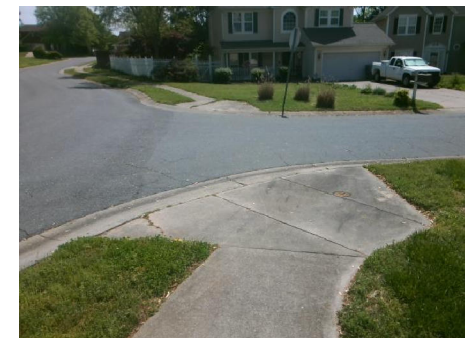
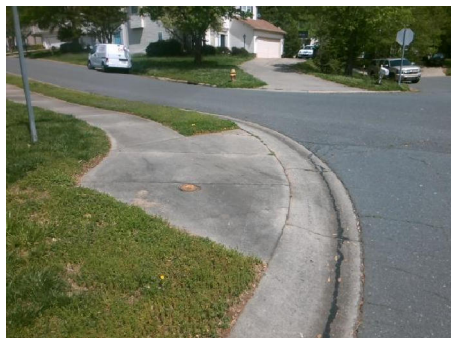
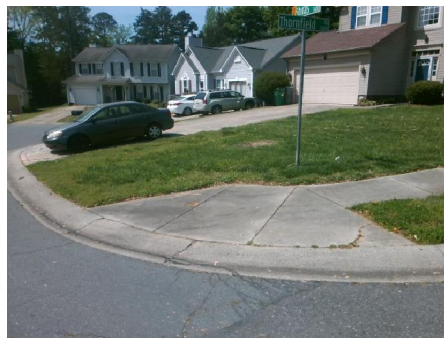
Not Found, R304.5.3

Compliance	Description	Data	Compliance	Description	Data
N/A	Ramp Length (in)	97.0	Yes	BlendTrans Slope (%)	4.1
Yes	Ramp Width (in)	86.0	No	BlendTrans XSlope (%)	5.8
N/A	Flare Type LT	N/A	N/A	Flare Type RT	N/A
N/A	Flare Slope LT (%)	N/A	N/A	Flare Slope RT (%)	N/A
N/A	Flare Traversable LT?	N/A	N/A	Flare Traversable RT?	N/A
N/A	Landing Length (in)	N/A	N/A	DWS Provided?	N/A
N/A	Landing Width (in)	N/A	N/A	DWS Contrast?	N/A
N/A	Landing Slope (%)	N/A	N/A	DWS Length (in)	N/A
N/A	Landing X Slope (%)	N/A	N/A	DWS Full Width?	N/A
N/A	Landing Curb? (Y/N)	N/A	N/A	DWS Offset (in)	N/A
N/A	Shared Landing?	N/A			
N/A	Gutter Ponding?	N/A	N/A	Gutter Slope (%)	N/A
N/A	Gutter Lip Ht (in)	N/A	N/A	Gutter X Slope (%)	N/A
N/A	Painted X Walk1?	No	N/A	Painted X Walk2?	No
	X Walk 1 Direction	To E		X Walk 2 Direction	To N
	X Walk 1 Width (in)	N/A		X Walk 2 Width (in)	N/A
	X Walk 1 Slope (%)	1.2		X Walk 2 Slope (%)	7.4
	X Walk 1 X Slope (%)	6.3		X Walk 2 X Slope (%)	0.7

N/A	Ramp inside XWalk1?	N/A	N/A	Ramp inside XWalk2?	N/A
	Road Slope (%)	8.6		Clear Space?	N/A
	Road X Slope (%)	4.3	N/A	Clear Space to XWalk (in)	N/A
N/A	Any Obstructions?	N/A	N/A	Storm Grate/Utility Hazard?	N/A
	Obstruction Type			Storm Grate/Utility Type	
		N/A			N/A
			Yes	Surface Condition? (G/P)	Good
			No	Curb Slope (%)	6.4

Remove & Replace Curb Ramp With Two New Directional Ramps or Equivalent.
