Access Compliance Report

Public Rights-of-Way

Intersection ID: 10272	Main Street: E_33RD_ST	Cross Street: N_DAVIDSON_ST	Location: SE
ADA ID: 100A3107D475	Ramp Type: Directional1	Initial Pass/Fail: Fail	Overall Compliance: No
		Severity Score: 10

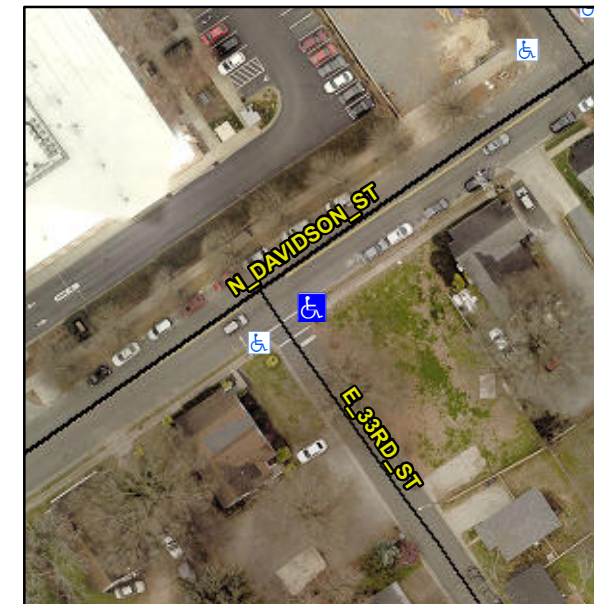
Compliance	Description	Data	Compliance	Description	Data
N/A	Ramp Length (in)	127.0	N/A	Grade Break?	N/A
No	Ramp Width (in)	46.0	N/A	Grade Break Slope (%)	0.0
Yes	Ramp Slope (%)	8.3	N/A	Grade Break XSlope (%)	0.0
No	Ramp XSlope (%)	3.2			
N/A	Flare Type LT	N/A	N/A	Flare Type RT	N/A
N/A	Flare Slope LT (%)	N/A	N/A	Flare Slope RT (%)	0.0
N/A	Flare Traversable LT?	N/A	N/A	Flare Traversable RT?	N/A
N/A	Landing Length (in)	0.0	N/A	DWS Provided?	N/A
N/A	Landing Width (in)	0.0	N/A	DWS Contrast?	N/A
N/A	Landing Slope (%)	0.0	N/A	DWS Length (in)	N/A
N/A	Landing X Slope (%)	0.0	N/A	DWS Full Width?	N/A
N/A	Landing Curb? (Y/N)	N/A	N/A	DWS Offset LT (in)	N/A
N/A	Shared Landing?	N/A	N/A	DWS Offset RT (in)	N/A
N/A	Gutter Ponding?	0.0	N/A	Gutter Slope (%)	N/A
N/A	Gutter Lip Ht (in)	0.0	N/A	Gutter X Slope (%)	N/A
N/A	Painted X Walk1?	Yes		Road Slope (%)	0.3
	X Walk 1 Direction	To SW		Road X Slope (%)	2.1
	X Walk 1 Width (in)	110.0		Clear Space?	N/A

X Walk 1 Slope (%)	0.3	N/A	Clear Space to XWalk (in)	N/A
	X Walk 1 X Slope (%)	2.1	N/A	Storm Grate/Utility Hazard?	N/A
N/A	Ramp inside XWalk1?	Yes		Storm Grate/Utility Type	
N/A	Any Obstructions?	N/A			N/A
	Obstruction Type		Yes	Surface Condition? (G/P)	Good
			N/A	Curb Slope (%)	7.7

Remove & Replace Entire Ramp.

R304.5.1, R304.5.3
