Access Compliance Report

Public Rights-of-Way

(Curb Ramps)

Intersection ID: 11669	Main Street: STONEYBROOK_RD	Cross Street: COUNTRY CLUB_DR	Location: NE
ADA ID: 10108AF02C1F	Ramp Type: Perp	Initial Pass/Fail: Fail	Overall Compliance: No
Severity Score: 35			
Codes/Mitigation Info/Possible Solution		Field Measurements/Component Compliance

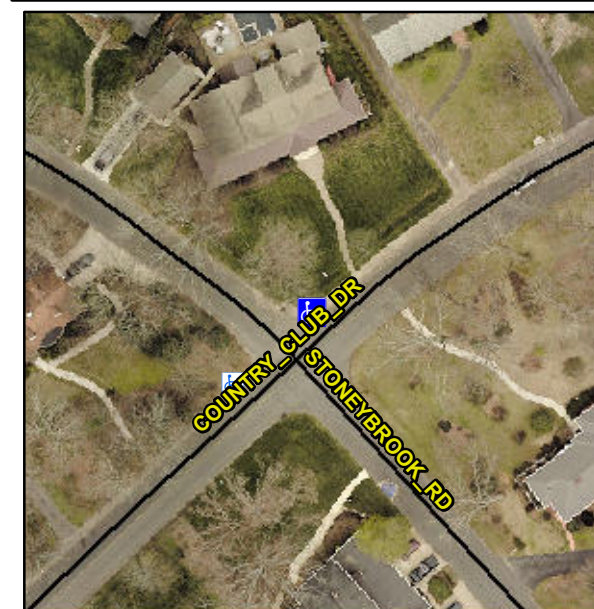
Compliance	Description	Data	Compliance	Description	Data
N/A	Ramp Length (in)	54.0	No	Ramp Slope (%)	12.6
No	Ramp Width (in)	38.0	No	Ramp XSlope (%)	3.1
N/A	Flare Type LT	N/A	N/A	Flare Type RT	N/A
N/A	Flare Slope LT (%)	N/A	N/A	Flare Slope RT (%)	N/A
N/A	Flare Traversable LT?	N/A	N/A	Flare Traversable RT?	N/A
N/A	Landing Length (in)	N/A	N/A	DWS Provided?	N/A
N/A	Landing Width (in)	N/A	N/A	DWS Contrast?	N/A
N/A	Landing Slope (%)	N/A	N/A	DWS Length (in)	N/A
N/A	Landing X Slope (%)	N/A	N/A	DWS Full Width?	N/A
N/A	Landing Curb? (Y/N)	N/A	N/A	DWS Offset (in)	N/A
N/A	Shared Landing?	N/A			
N/A	Gutter Ponding?	N/A	N/A	Gutter Slope (%)	N/A
N/A	Gutter Lip Ht (in)	N/A	N/A	Gutter X Slope (%)	N/A
N/A	Painted X Walk1?	No	N/A	Painted X Walk2?	N/A
	X Walk 1 Direction	To SW		X Walk 2 Direction	N/A
N/A	X Walk 1 Width (in)	N/A	N/A	X Walk 2 Width (in)	N/A
	X Walk 1 Slope (%)	0.3		X Walk 2 Slope (%)	N/A
	X Walk 1 X Slope (%)	1.5		X Walk 2 X Slope (%)	N/A

N/A	Ramp inside XWalk1?	N/A	N/A	Ramp inside XWalk2?	N/A
	Road Slope (%)	N/A	N/A	Clear Space?	N/A
	Road X Slope (%)	N/A	N/A	Clear Space to XWalk (in)	N/A
N/A	Any Obstructions?	N/A	N/A	Storm Grate/Utility Hazard?	N/A
	Obstruction Type			Storm Grate/Utility Type	
		N/A			N/A
			Yes	Surface Condition? (G/P)	Good

Possible Solutions:

Remove & Replace Entire Ramp.

R304.5.1, R304.2.2, R304.5.3
