Access Compliance Report

Public Rights-of-Way

(Curb Ramps)

Intersection ID: 13056	Main Street: S_MINT_ST	Cross Street: W_BLAND_ST	Location: N
ADA ID: 1014E9032636	Ramp Type: PerpDiag	Initial Pass/Fail: Fail	Overall Compliance: No
Severity Score: 8.75			
Codes/Mitigation Info/Possible Solution		Field Measurements/Component Compliance

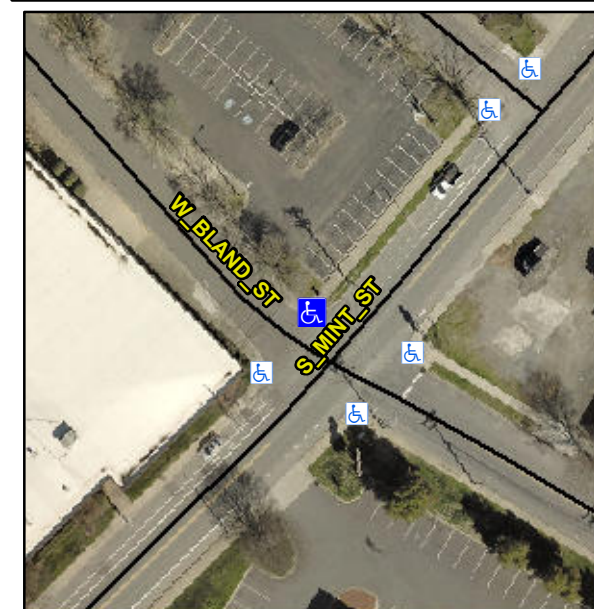
Compliance	Description	Data	Compliance	Description	Data
N/A	Ramp Length (in)	54.0	Yes	Ramp Slope (%)	5.5
No	Ramp Width (in)	45.0	Yes	Ramp XSlope (%)	0.1
N/A	Flare Type LT	N/A	N/A	Flare Type RT	N/A
N/A	Flare Slope LT (%)	N/A	N/A	Flare Slope RT (%)	N/A
N/A	Flare Traversable LT?	N/A	N/A	Flare Traversable RT?	N/A
N/A	Landing Length (in)	N/A	N/A	DWS Provided?	N/A
N/A	Landing Width (in)	N/A	N/A	DWS Contrast?	N/A
N/A	Landing Slope (%)	N/A	N/A	DWS Length (in)	N/A
N/A	Landing X Slope (%)	N/A	N/A	DWS Full Width?	N/A
N/A	Landing Curb? (Y/N)	N/A	N/A	DWS Offset (in)	N/A
N/A	Shared Landing?	N/A			
N/A	Gutter Ponding?	N/A	N/A	Gutter Slope (%)	N/A
N/A	Gutter Lip Ht (in)	N/A	N/A	Gutter X Slope (%)	N/A
N/A	Painted X Walk1?	No	N/A	Painted X Walk2?	No
	X Walk 1 Direction	To SW		X Walk 2 Direction	To SE
N/A	X Walk 1 Width (in)	N/A	N/A	X Walk 2 Width (in)	N/A
	X Walk 1 Slope (%)	3.2		X Walk 2 Slope (%)	2.3
	X Walk 1 X Slope (%)	0.6		X Walk 2 X Slope (%)	1.4

N/A	Ramp inside XWalk1?	N/A	N/A	Ramp inside XWalk2?	N/A
	Road Slope (%)	0.2	N/A	Clear Space?	N/A
	Road X Slope (%)	3.5	N/A	Clear Space to XWalk (in)	N/A
N/A	Any Obstructions?	N/A	N/A	Storm Grate/Utility Hazard?	N/A
	Obstruction Type			Storm Grate/Utility Type	
		N/A			N/A
		Yes		Surface Condition? (G/P)	Good

Possible Solutions:

Remove & Replace Curb Ramp With Two New Directional Ramps or Equivalent.

R304.5.1

Total Cost: \$ 3200.00
