# Access Compliance Report

## Public Rights-of-Way

### (Curb Ramps)

Intersection ID: 10023159	Main Street: CHARLOTTE_VIEW_DR	Cross Street: N/A	Location: SE
ADA ID: 101926A1FABC	Ramp Type: Perp	Initial Pass/Fail: Fail	Overall Compliance: No
		Severity Score: 25

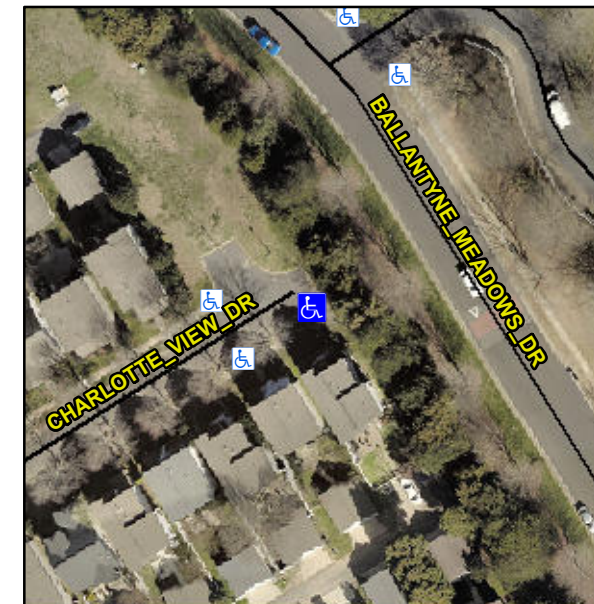
Compliance	Description	Data	Compliance	Description	Data
N/A	Ramp Length (in)	48.0	No	Ramp Slope (%)	15.4
Yes	Ramp Width (in)	48.0	Yes	Ramp XSlope (%)	0.1
N/A	Flare Type LT	N/A	N/A	Flare Type RT	N/A
N/A	Flare Slope LT (%)	N/A	N/A	Flare Slope RT (%)	N/A
N/A	Flare Traversable LT?	N/A	N/A	Flare Traversable RT?	N/A
N/A	Landing Length (in)	N/A	N/A	DWS Provided?	N/A
N/A	Landing Width (in)	N/A	N/A	DWS Contrast?	N/A
N/A	Landing Slope (%)	N/A	N/A	DWS Length (in)	N/A
N/A	Landing X Slope (%)	N/A	N/A	DWS Full Width?	N/A
N/A	Landing Curb? (Y/N)	N/A	N/A	DWS Offset (in)	N/A
N/A	Shared Landing?	N/A			
N/A	Gutter Ponding?	N/A	N/A	Gutter Slope (%)	N/A
N/A	Gutter Lip Ht (in)	N/A	N/A	Gutter X Slope (%)	N/A
N/A	Painted X Walk1?	No	N/A	Painted X Walk2?	N/A
	X Walk 1 Direction	To NW		X Walk 2 Direction	N/A
N/A	X Walk 1 Width (in)	N/A	N/A	X Walk 2 Width (in)	N/A
	X Walk 1 Slope (%)	1.5		X Walk 2 Slope (%)	N/A
	X Walk 1 X Slope (%)	1.5		X Walk 2 X Slope (%)	N/A

N/A	Ramp inside XWalk1?	N/A	N/A	Ramp inside XWalk2?	N/A
	Road Slope (%)	N/A	N/A	Clear Space?	N/A
	Road X Slope (%)	N/A	N/A	Clear Space to XWalk (in)	N/A
N/A	Any Obstructions?	N/A	N/A	Storm Grate/Utility Hazard?	N/A
	Obstruction Type			Storm Grate/Utility Type	
		N/A			N/A
			Yes	Surface Condition? (G/P)	Good

**Remove & Replace Entire Ramp.**

**R304.2.2**

**\$ 1850.00**
