# Access Compliance Report

## Public Rights-of-Way

### (Curb Ramps)

Intersection ID: N/A	Main Street: MACDARA_GLENN_CT	Cross Street: FIVE_KNOLLS_DR	Location: NE
ADA ID: 101A329D06A6	Ramp Type: PerpDiag	Initial Pass/Fail: Fail	Overall Compliance: No
		Severity Score: 8.75

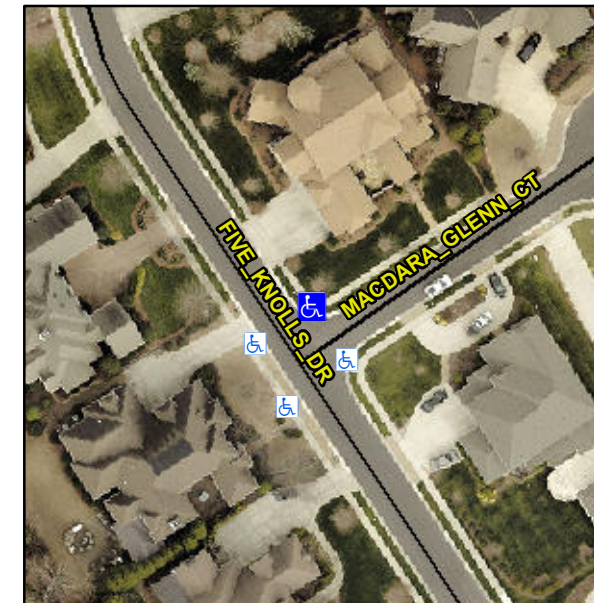
**Not Found, R304.5.1**

Compliance	Description	Data	Compliance	Description	Data
N/A	Ramp Length (in)	50.0	Yes	Ramp Slope (%)	5.2
No	Ramp Width (in)	46.0	Yes	Ramp XSlope (%)	1.4
N/A	Flare Type LT	N/A	N/A	Flare Type RT	N/A
N/A	Flare Slope LT (%)	N/A	N/A	Flare Slope RT (%)	N/A
N/A	Flare Traversable LT?	N/A	N/A	Flare Traversable RT?	N/A
N/A	Landing Length (in)	N/A	N/A	DWS Provided?	N/A
N/A	Landing Width (in)	N/A	N/A	DWS Contrast?	N/A
N/A	Landing Slope (%)	N/A	N/A	DWS Length (in)	N/A
N/A	Landing X Slope (%)	N/A	N/A	DWS Full Width?	N/A
N/A	Landing Curb? (Y/N)	N/A	N/A	DWS Offset (in)	N/A
N/A	Shared Landing?	N/A			
N/A	Gutter Ponding?	N/A	N/A	Gutter Slope (%)	N/A
N/A	Gutter Lip Ht (in)	N/A	N/A	Gutter X Slope (%)	N/A
N/A	Painted X Walk1?	No	N/A	Painted X Walk2?	No
	X Walk 1 Direction	To W		X Walk 2 Direction	To S
N/A	X Walk 1 Width (in)	N/A	N/A	X Walk 2 Width (in)	N/A
	X Walk 1 Slope (%)	3.2		X Walk 2 Slope (%)	3.0
	X Walk 1 X Slope (%)	3.1		X Walk 2 X Slope (%)	1.7

N/A	Ramp inside XWalk1?	N/A	N/A	Ramp inside XWalk2?	N/A
	Road Slope (%)	0.2	N/A	Clear Space?	N/A
	Road X Slope (%)	2.8	N/A	Clear Space to XWalk (in)	N/A
N/A	Any Obstructions?	N/A	N/A	Storm Grate/Utility Hazard?	N/A
	Obstruction Type			Storm Grate/Utility Type	
		N/A			N/A
			Yes	Surface Condition? (G/P)	Good

**Remove & Replace Curb Ramp With Two New Directional Ramps or Equivalent.**

Total Cost: \$ 3200.00
