N/A

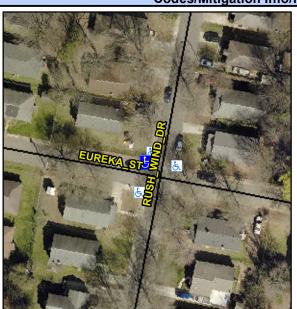
Intersection ID: 9403 Main Street: EUREKA_ST Cross Street: RUSH_WIND_DR Location: N

Street 1 Name EUREKA ST
Stop Condition-Street 2 StopSign
Street 2 Name N/A
Stop Condition-Street 1 N/A
