Access Compliance Report Public Rights-of-Way (Curb Ramps)

Main Street: SUMMIT GREENWAY CT **Cross Street: S SUMMIT AV** Location: W Intersection ID: 48646 Ramp Type: BlendTrans1 Initial Pass/Fail: Fail **Overall Compliance: No** 10 ADA ID: 102C9D2A6E75 **Severity Score:**

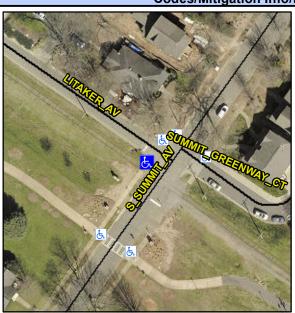
Not Found, R304.5.1, R304.5.3

N/A	Ramp Length (in)	62.0	Yes	BlendTrans Slope (%)
No	Ramp Width (in)	38.0	No	BlendTrans XSlope (%)
N/A	Flare Type LT	N/A	N/A	Flare Type RT
N/A	Flare Slope LT (%)	N/A	N/A	Flare Slope RT (%)
N/A	Flare Traversable LT?	N/A	N/A	Flare Traversable RT?
N/A	Landing Length (in)	N/A	N/A	DWS Provided?
N/A	Landing Width (in)	N/A	N/A	DWS Contrast?
N/A	Landing Slope (%)	N/A	N/A	DWS Length (in)
N/A	Landing X Slope (%)	N/A	N/A	DWS Full Width?
N/A	Landing Curb? (Y/N)	N/A	N/A	DWS Offset (in)
N/A	Shared Landing?	N/A		
N/A	Gutter Ponding?	N/A	N/A	Gutter Slope (%)
N/A	Gutter Lip Ht (in)	N/A	N/A	Gutter X Slope (%)
N/A	Painted X Walk1?	No	N/A	Painted X Walk2?
	X Walk 1 Direction	To N		X Walk 2 Direction
	X Walk 1 Width (in)	N/A		X Walk 2 Width (in)
	X Walk 1 Slope (%)	2.5		X Walk 2 Slope (%)
	X Walk 1 X Slope (%)	1.8		X Walk 2 X Slope (%)
N/A	Ramp inside XWalk1?	N/A	N/A	Ramp inside XWalk2?
	Road Slope (%)	1.8		Clear Space?
	Road X Slope (%)	2.5	N/A	Clear Space to XWalk (in)

LITAKER AV Street 1 Name Stop Condition-Street 1 StopSign Street 2 Name N/A Stop Condition-Street 2 N/A Remove & Replace Curb Ramp With Two New Directional Ramps or Equivalent.
