# Access Compliance Report

## Public Rights-of-Way

### (Curb Ramps)

| Intersection ID: 24499 | Main Street: BECKMORE_PL | Cross Street: SAINTFIELD_PL | Location: SE |

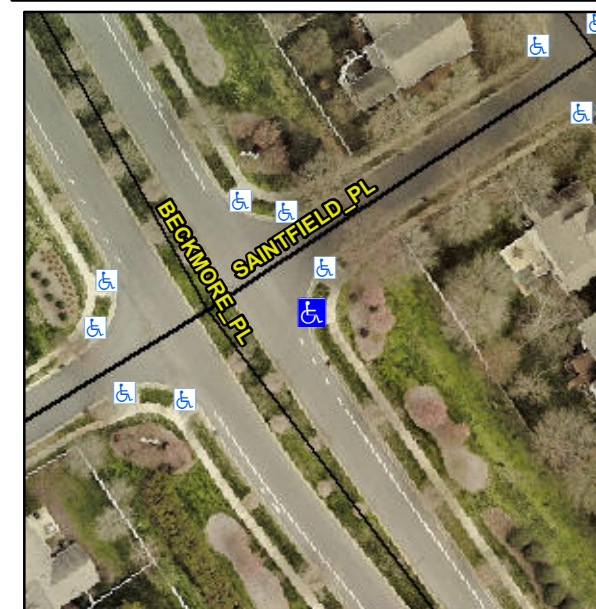
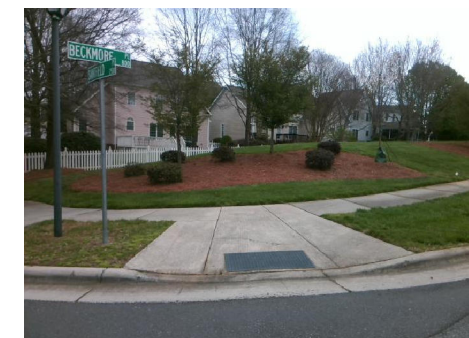
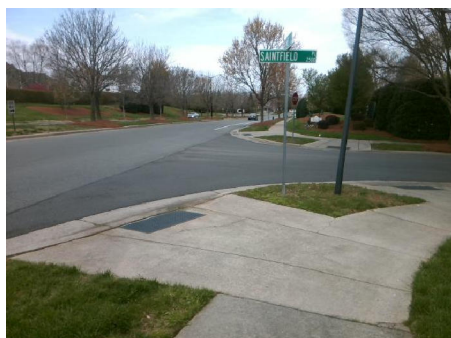
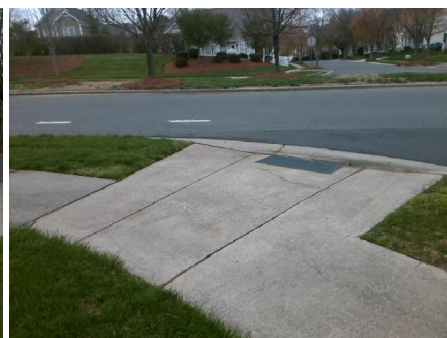
| ADA ID: 102F38937B1A | Ramp Type: Perp | Initial Pass/Fail: Pass | Overall Compliance: No |

| Severity Score: 7.75 | | | |

**Not Found, R304.5.3, R304.2.2-Perp,  
R304.3.2-Para, R305.1.4, R305.2,  
R304.5.4**

| Compliance | Description | Data | Compliance | Description | Data |
|---|---|---|---|---|---|
| Yes | Ramp Width (in) | 50.0 | No | Ramp XSlope (%) | 4.2 |
| No | Landing Slope (%) | 4.1 | Yes | DWS Length (in) | 25.5 |
| No | Landing X Slope (%) | 6.1 | No | DWS Full Width? | No |
| N/A | Landing Curb? (Y/N) | No | No | DWS Offset (in) | 3.0 |
| Yes | Gutter Ponding? | No | No | Gutter Slope (%) | 5.2 |

**Remove & Replace Entire Ramp.  
Remove & Replace Gutter.**

Total Cost: \$ 2600.00
