Access Compliance Report

Public Rights-of-Way

(Curb Ramps)

Intersection ID: 15563	Main Street: GRANVILLE_RD	Cross Street: QUEENS_RD	Location: SW
ADA ID: 103171F63977	Ramp Type: Perp	Initial Pass/Fail: Fail	Overall Compliance: No
Severity Score: 21.25			
Codes/Mitigation Info/Possible Solution		Field Measurements/Component Compliance

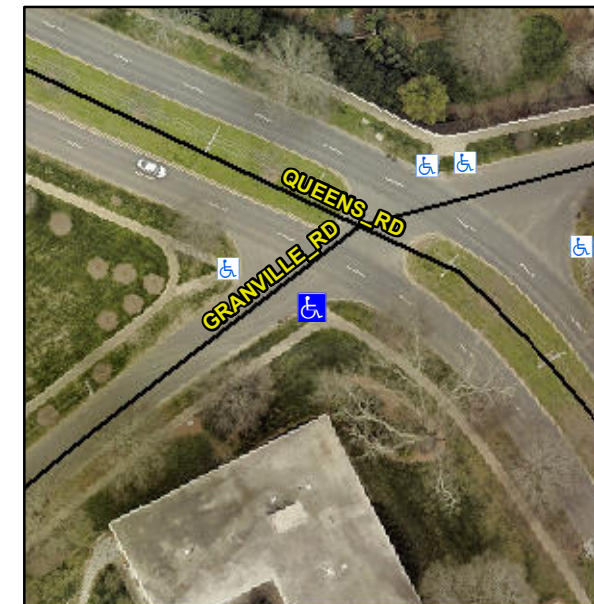
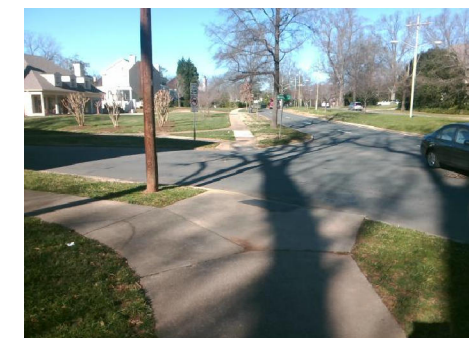
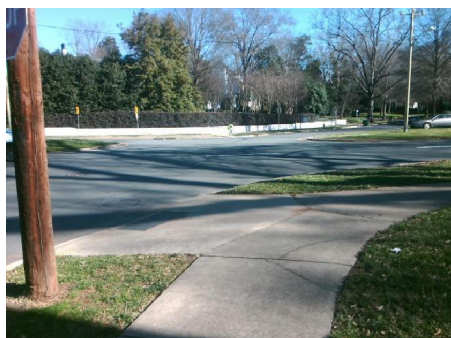
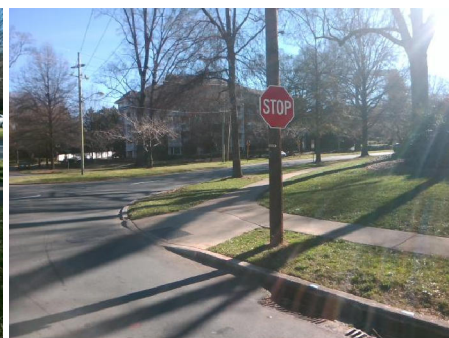
Not Found, R304.5.1, R304.2.2

Compliance	Description	Data	Compliance	Description	Data
N/A	Ramp Length (in)	90.0	No	Ramp Slope (%)	10.8
No	Ramp Width (in)	44.0	Yes	Ramp XSlope (%)	0.1
N/A	Flare Type LT	N/A	N/A	Flare Type RT	N/A
N/A	Flare Slope LT (%)	N/A	N/A	Flare Slope RT (%)	N/A
N/A	Flare Traversable LT?	N/A	N/A	Flare Traversable RT?	N/A
N/A	Landing Length (in)	N/A	N/A	DWS Provided?	N/A
N/A	Landing Width (in)	N/A	N/A	DWS Contrast?	N/A
N/A	Landing Slope (%)	N/A	N/A	DWS Length (in)	N/A
N/A	Landing X Slope (%)	N/A	N/A	DWS Full Width?	N/A
N/A	Landing Curb? (Y/N)	N/A	N/A	DWS Offset (in)	N/A
N/A	Shared Landing?	N/A			
N/A	Gutter Ponding?	N/A	N/A	Gutter Slope (%)	N/A
N/A	Gutter Lip Ht (in)	N/A	N/A	Gutter X Slope (%)	N/A
N/A	Painted X Walk1?	No	N/A	Painted X Walk2?	N/A
	X Walk 1 Direction	To NW		X Walk 2 Direction	N/A
N/A	X Walk 1 Width (in)	N/A	N/A	X Walk 2 Width (in)	N/A
	X Walk 1 Slope (%)	0.3		X Walk 2 Slope (%)	N/A
	X Walk 1 X Slope (%)	3.8		X Walk 2 X Slope (%)	N/A

N/A	Ramp inside XWalk1?	N/A	N/A	Ramp inside XWalk2?	N/A
	Road Slope (%)	N/A	N/A	Clear Space?	N/A
	Road X Slope (%)	N/A	N/A	Clear Space to XWalk (in)	N/A
N/A	Any Obstructions?	N/A	N/A	Storm Grate/Utility Hazard?	N/A
	Obstruction Type			Storm Grate/Utility Type	
		N/A			N/A
			Yes	Surface Condition? (G/P)	Good

Remove & Replace Entire Ramp.
