Access Compliance Report

Public Rights-of-Way

(Curb Ramps)

Intersection ID: 30176	Main Street: FAIRSTONE_AV	Cross Street: MENTONE_LN	Location: W
ADA ID: 10381245E804	Ramp Type: BlendTrans2	Initial Pass/Fail: Fail	Overall Compliance: No
Severity Score: 10			
Codes/Mitigation Info/Possible Solution		Field Measurements/Component Compliance

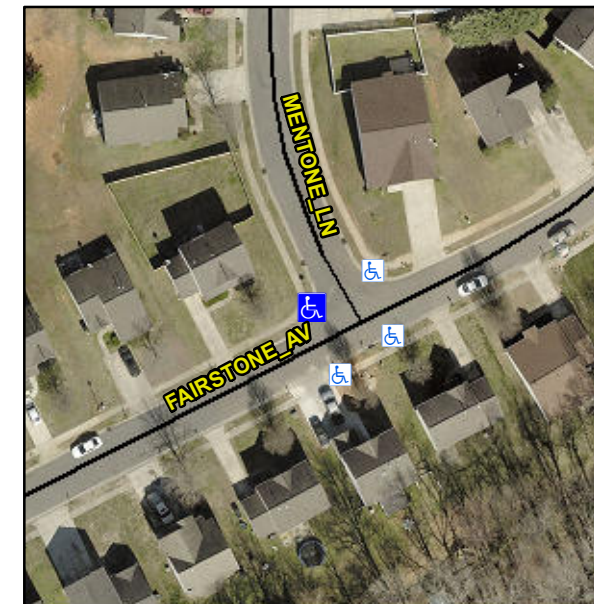
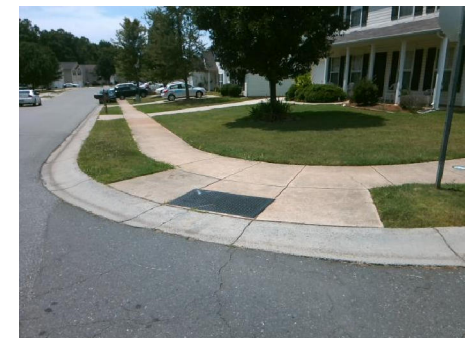
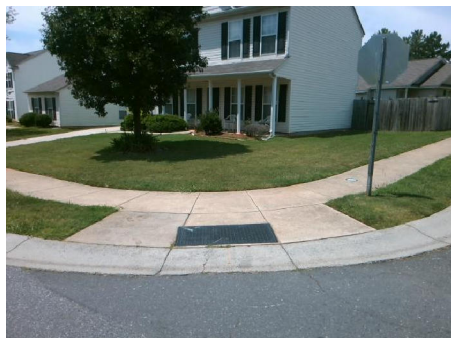
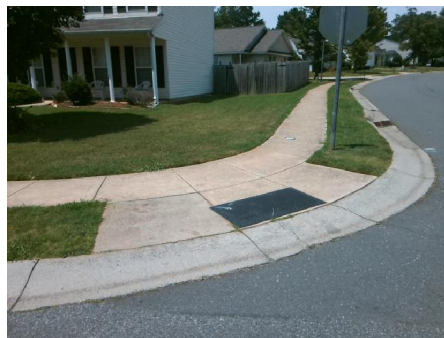
NO LNDG

Not Found, R304.5.1, R304.5.3

Compliance	Description	Data	Compliance	Description	Data
N/A	Ramp Length (in)	96.0	Yes	BlendTrans Slope (%)	2.5
No	Ramp Width (in)	41.0	No	BlendTrans XSlope (%)	3.8
N/A	Flare Type LT	N/A	N/A	Flare Type RT	N/A
N/A	Flare Slope LT (%)	N/A	N/A	Flare Slope RT (%)	N/A
N/A	Flare Traversable LT?	N/A	N/A	Flare Traversable RT?	N/A
N/A	Landing Length (in)	N/A	N/A	DWS Provided?	N/A
N/A	Landing Width (in)	N/A	N/A	DWS Contrast?	N/A
N/A	Landing Slope (%)	N/A	N/A	DWS Length (in)	N/A
N/A	Landing X Slope (%)	N/A	N/A	DWS Full Width?	N/A
N/A	Landing Curb? (Y/N)	N/A	N/A	DWS Offset (in)	N/A
N/A	Shared Landing?	N/A			
N/A	Gutter Ponding?	N/A	N/A	Gutter Slope (%)	N/A
N/A	Gutter Lip Ht (in)	N/A	N/A	Gutter X Slope (%)	N/A
N/A	Painted X Walk1?	No	N/A	Painted X Walk2?	No
	X Walk 1 Direction	To SE		X Walk 2 Direction	To NE
	X Walk 1 Width (in)	N/A		X Walk 2 Width (in)	N/A
	X Walk 1 Slope (%)	0.8		X Walk 2 Slope (%)	2.3
	X Walk 1 X Slope (%)	3.0		X Walk 2 X Slope (%)	2.2

N/A	Ramp inside XWalk1?	N/A	N/A	Ramp inside XWalk2?	N/A
	Road Slope (%)	1.1		Clear Space?	N/A
	Road X Slope (%)	1.1	N/A	Clear Space to XWalk (in)	N/A
N/A	Any Obstructions?	N/A	N/A	Storm Grate/Utility Hazard?	N/A
	Obstruction Type			Storm Grate/Utility Type	
		N/A			N/A
			Yes	Surface Condition? (G/P)	Good
			No	Curb Slope (%)	14.0

Possible Solutions:

Remove & Replace Curb Ramp With Two New Directional Ramps or Equivalent.
