# Access Compliance Report

## Public Rights-of-Way

### (Curb Ramps)

| Intersection ID: 47848 | Main Street: ADOBE_RD | Cross Street: SERAPE_RD | Location: SW |

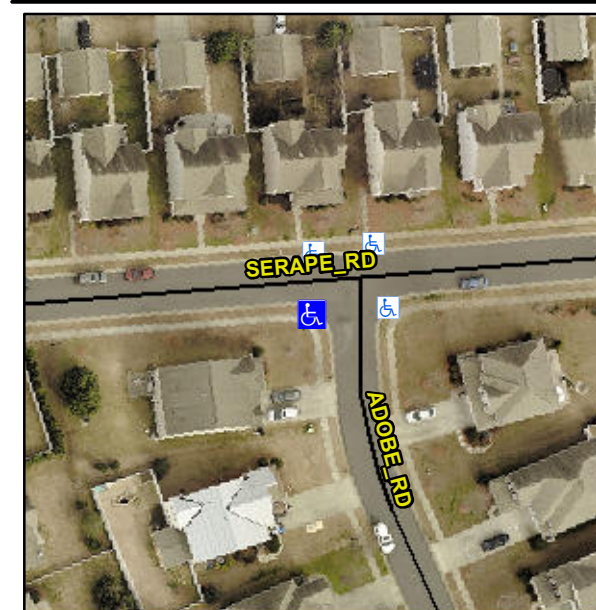
| ADA ID: 103C3CFB4698 | Ramp Type: PerpDiag | Initial Pass/Fail: Fail | Overall Compliance: No |
| Severity Score: 21.25 | | | |

**Not Found, R304.5.1, R304.5.3**

| Compliance | Description | Data | Compliance | Description | Data |
|---|---|---|---|---|---|
| N/A | Ramp Length (in) | 47.0 | Yes | Ramp Slope (%) | 6.9 |
| No | Ramp Width (in) | 47.0 | No | Ramp XSlope (%) | 5.4 |

**Remove & Replace Curb Ramp With Two New Directional Ramps or Equivalent.**

Total Cost: \$ 3200.00
