# Access Compliance Report

## Public Rights-of-Way

### (Curb Ramps)

Intersection ID: 8289	Main Street: GRIER_RD	Cross Street: NEWELL-HICKORY GROVE_RD	Location: S
ADA ID: 1048ECE90189	Ramp Type: Perp	Initial Pass/Fail: Fail	Overall Compliance: No
Severity Score: 21.25			
Codes/Mitigation Info/Possible Solution		Field Measurements/Component Compliance

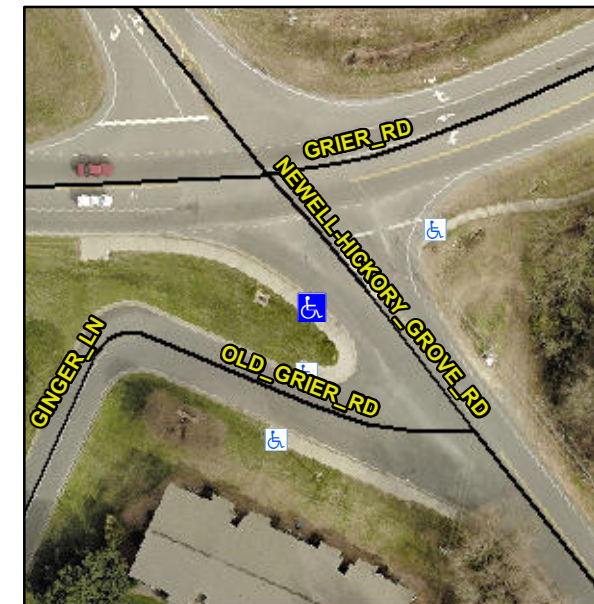
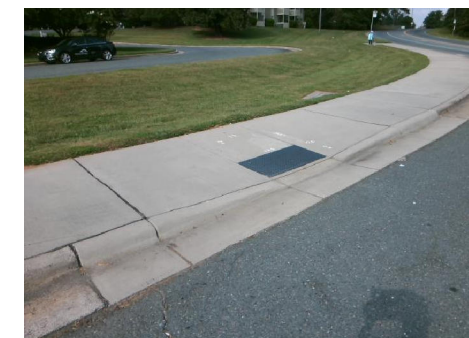
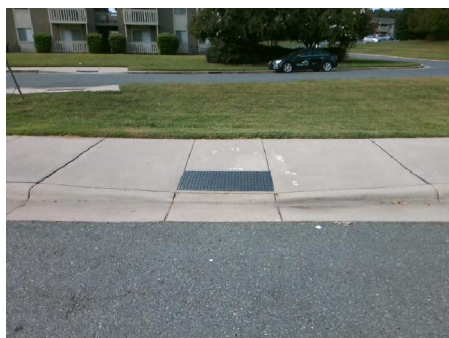
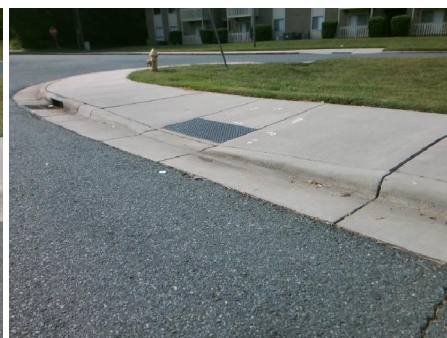
**Not Found, R304.5.1, R304.2.2**

Compliance	Description	Data	Compliance	Description	Data
N/A	Ramp Length (in)	84.5	No	Ramp Slope (%)	8.6
No	Ramp Width (in)	47.5	Yes	Ramp XSlope (%)	1.7
N/A	Flare Type LT	N/A	N/A	Flare Type RT	N/A
N/A	Flare Slope LT (%)	N/A	N/A	Flare Slope RT (%)	N/A
N/A	Flare Traversable LT?	N/A	N/A	Flare Traversable RT?	N/A
N/A	Landing Length (in)	N/A	N/A	DWS Provided?	N/A
N/A	Landing Width (in)	N/A	N/A	DWS Contrast?	N/A
N/A	Landing Slope (%)	N/A	N/A	DWS Length (in)	N/A
N/A	Landing X Slope (%)	N/A	N/A	DWS Full Width?	N/A
N/A	Landing Curb? (Y/N)	N/A	N/A	DWS Offset (in)	N/A
N/A	Shared Landing?	N/A			
N/A	Gutter Ponding?	N/A	N/A	Gutter Slope (%)	N/A
N/A	Gutter Lip Ht (in)	N/A	N/A	Gutter X Slope (%)	N/A
N/A	Painted X Walk1?	No	N/A	Painted X Walk2?	N/A
	X Walk 1 Direction	To E		X Walk 2 Direction	N/A
N/A	X Walk 1 Width (in)	N/A	N/A	X Walk 2 Width (in)	N/A
	X Walk 1 Slope (%)	0.8		X Walk 2 Slope (%)	N/A
	X Walk 1 X Slope (%)	0.0		X Walk 2 X Slope (%)	N/A

N/A	Ramp inside XWalk1?	N/A	N/A	Ramp inside XWalk2?	N/A
	Road Slope (%)	N/A	N/A	Clear Space?	N/A
	Road X Slope (%)	N/A	N/A	Clear Space to XWalk (in)	N/A
N/A	Any Obstructions?	N/A	N/A	Storm Grate/Utility Hazard?	N/A
	Obstruction Type			Storm Grate/Utility Type	
		N/A			N/A
			Yes	Surface Condition? (G/P)	Good

**Remove & Replace Entire Ramp.**
