Access Compliance Report

Public Rights-of-Way

(Curb Ramps)

Intersection ID: 15060	Main Street: DOROTHY_DR	Cross Street: IVERSON_WY	Location:	E
ADA ID: 10601EBD931E	Ramp Type: Directional1	Initial Pass/Fail: Fail	Overall Compliance: No	Severity Score: 1.25
Codes/Mitigation Info/Possible Solution		Field Measurements/Component Compliance

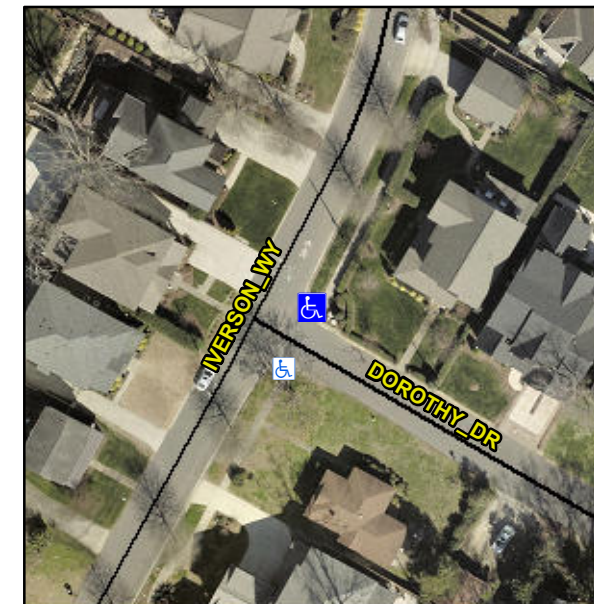
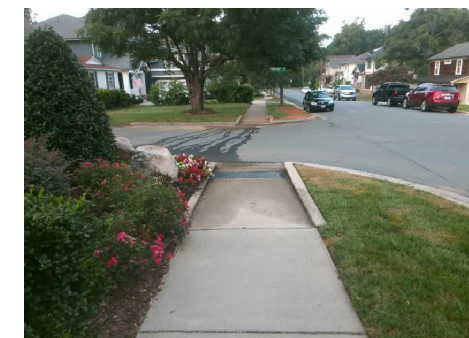
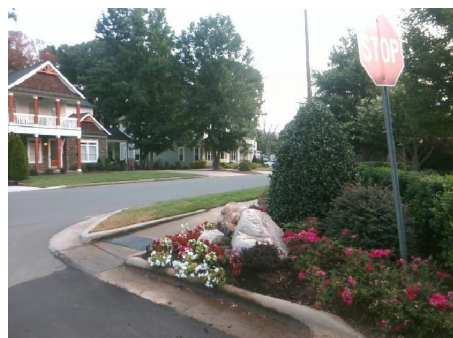
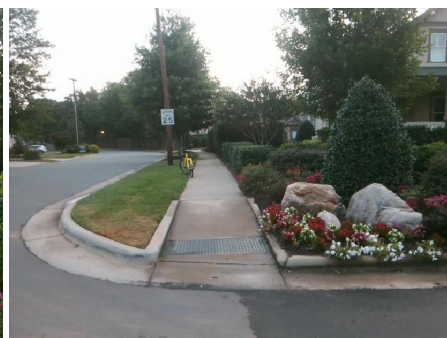
Compliance	Description	Data	Compliance	Description	Data
N/A	Ramp Length (in)	135.0	N/A	Grade Break?	N/A
Yes	Ramp Width (in)	58.0	N/A	Grade Break Slope (%)	0.0
Yes	Ramp Slope (%)	6.7	N/A	Grade Break XSlope (%)	0.0
No	Ramp XSlope (%)	3.4			
N/A	Flare Type LT	N/A	N/A	Flare Type RT	N/A
N/A	Flare Slope LT (%)	N/A	N/A	Flare Slope RT (%)	0.0
N/A	Flare Traversable LT?	N/A	N/A	Flare Traversable RT?	N/A
N/A	Landing Length (in)	0.0	N/A	DWS Provided?	N/A
N/A	Landing Width (in)	0.0	N/A	DWS Contrast?	N/A
N/A	Landing Slope (%)	0.0	N/A	DWS Length (in)	N/A
N/A	Landing X Slope (%)	0.0	N/A	DWS Full Width?	N/A
N/A	Landing Curb? (Y/N)	N/A	N/A	DWS Offset LT (in)	N/A
N/A	Shared Landing?	N/A	N/A	DWS Offset RT (in)	N/A
N/A	Gutter Ponding?	0.0	N/A	Gutter Slope (%)	N/A
N/A	Gutter Lip Ht (in)	0.0	N/A	Gutter X Slope (%)	N/A
N/A	Painted X Walk1?	No		Road Slope (%)	1.7
	X Walk 1 Direction	To S		Road X Slope (%)	0.9
	X Walk 1 Width (in)	N/A		Clear Space?	N/A

X Walk 1 Slope (%)	1.7	N/A	Clear Space to XWalk (in)	N/A
	X Walk 1 X Slope (%)	0.9	N/A	Storm Grate/Utility Hazard?	N/A
N/A	Ramp inside XWalk1?	N/A		Storm Grate/Utility Type	
N/A	Any Obstructions?	N/A			N/A
	Obstruction Type		Yes	Surface Condition? (G/P)	Good
			N/A	Curb Slope (%)	8.7

Remove & Replace Entire Ramp.

R304.5.3
