Access Compliance Report

Public Rights-of-Way

(Curb Ramps)

Intersection ID: N/A	Main Street: SUMMERFIELD RIDGE LN	Cross Street: LITTLE SRREAM CT	Location: SW
ADA ID: 10626079866D	Ramp Type: PerpDiag	Initial Pass/Fail: Fail	Overall Compliance: No
		Severity Score: 50

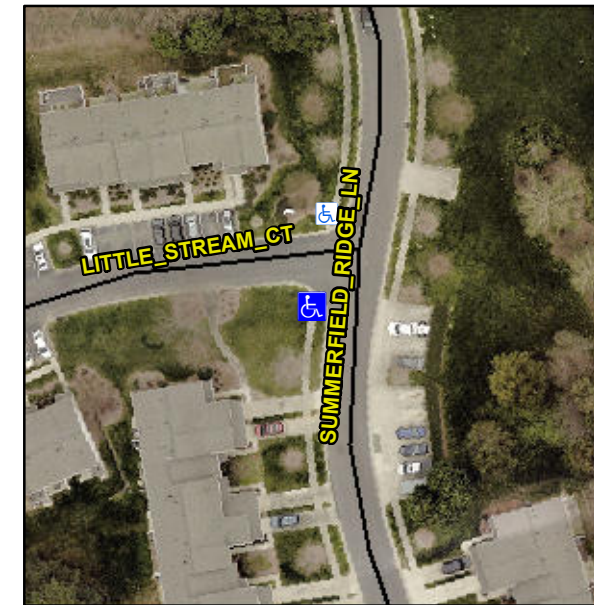
Compliance	Description	Data	Compliance	Description	Data
N/A	Ramp Length (in)	57.0	No	Ramp Slope (%)	14.4
Yes	Ramp Width (in)	57.0	No	Ramp XSlope (%)	8.0
N/A	Flare Type LT	N/A	N/A	Flare Type RT	N/A
N/A	Flare Slope LT (%)	N/A	N/A	Flare Slope RT (%)	N/A
N/A	Flare Traversable LT?	No	N/A	Flare Traversable RT?	No
N/A	Landing Length (in)	N/A	N/A	DWS Provided?	N/A
N/A	Landing Width (in)	N/A	N/A	DWS Contrast?	N/A
N/A	Landing Slope (%)	N/A	N/A	DWS Length (in)	N/A
N/A	Landing X Slope (%)	N/A	N/A	DWS Full Width?	N/A
N/A	Landing Curb? (Y/N)	N/A	N/A	DWS Offset (in)	N/A
N/A	Shared Landing?	N/A			
N/A	Gutter Ponding?	N/A	N/A	Gutter Slope (%)	N/A
N/A	Gutter Lip Ht (in)	N/A	N/A	Gutter X Slope (%)	N/A
N/A	Painted X Walk1?	No	N/A	Painted X Walk2?	No
	X Walk 1 Direction	To E		X Walk 2 Direction	To N
N/A	X Walk 1 Width (in)	N/A	N/A	X Walk 2 Width (in)	N/A
	X Walk 1 Slope (%)	2.5		X Walk 2 Slope (%)	1.5
	X Walk 1 X Slope (%)	1.8		X Walk 2 X Slope (%)	3.1

N/A	Ramp inside XWalk1?	N/A	N/A	Ramp inside XWalk2?	N/A
	Road Slope (%)	4.2	N/A	Clear Space?	N/A
	Road X Slope (%)	0.7	N/A	Clear Space to XWalk (in)	N/A
N/A	Any Obstructions?	N/A	N/A	Storm Grate/Utility Hazard?	N/A
	Obstruction Type			Storm Grate/Utility Type	
		N/A			N/A
			Yes	Surface Condition? (G/P)	Good

Remove & Replace Curb Ramp With Two New Directional Ramps or Equivalent.

R304.2.2, R304.5.3
