Access Compliance Report

Public Rights-of-Way

(Curb Ramps)

Intersection ID: N/A	Main Street: GLENBURN_LN	Cross Street: MOSSDALE_LN	Location: NE
ADA ID: 1078FEE18161	Ramp Type: PerpDiag	Initial Pass/Fail: Fail	Overall Compliance: No
Severity Score: 1.25			
Codes/Mitigation Info/Possible Solution		Field Measurements/Component Compliance

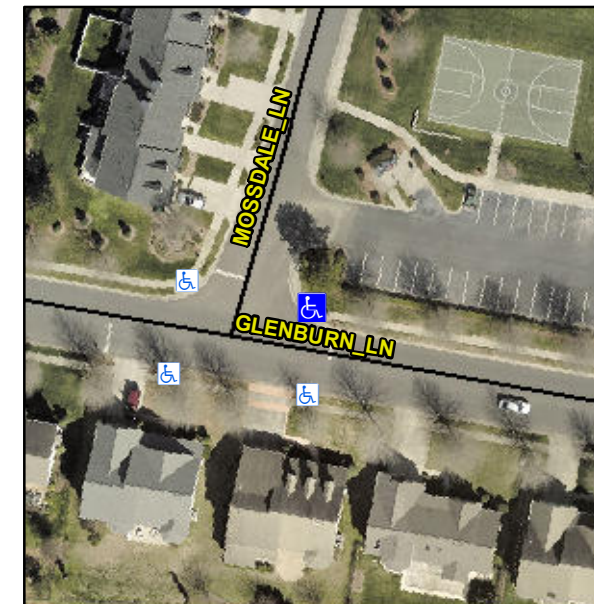
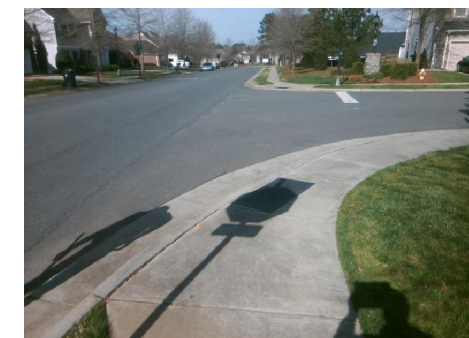
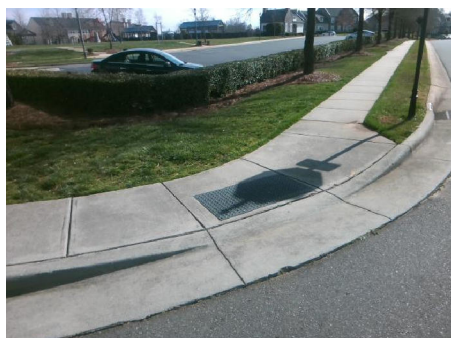
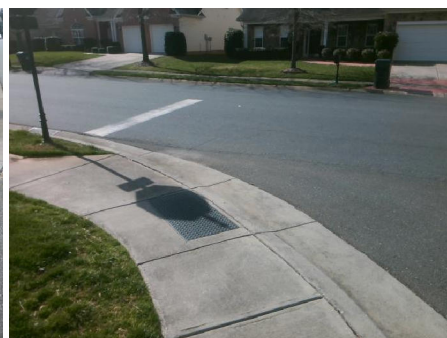
Not Found, R304.5.3

Compliance	Description	Data	Compliance	Description	Data
N/A	Ramp Length (in)	49.0	Yes	Ramp Slope (%)	5.8
Yes	Ramp Width (in)	52.0	No	Ramp XSlope (%)	2.3
N/A	Flare Type LT	N/A	N/A	Flare Type RT	N/A
N/A	Flare Slope LT (%)	N/A	N/A	Flare Slope RT (%)	N/A
N/A	Flare Traversable LT?	N/A	N/A	Flare Traversable RT?	N/A
N/A	Landing Length (in)	N/A	N/A	DWS Provided?	N/A
N/A	Landing Width (in)	N/A	N/A	DWS Contrast?	N/A
N/A	Landing Slope (%)	N/A	N/A	DWS Length (in)	N/A
N/A	Landing X Slope (%)	N/A	N/A	DWS Full Width?	N/A
N/A	Landing Curb? (Y/N)	N/A	N/A	DWS Offset (in)	N/A
N/A	Shared Landing?	N/A			
N/A	Gutter Ponding?	N/A	N/A	Gutter Slope (%)	N/A
N/A	Gutter Lip Ht (in)	1.0	N/A	Gutter X Slope (%)	N/A
N/A	Painted X Walk1?	No	N/A	Painted X Walk2?	No
	X Walk 1 Direction	To NW		X Walk 2 Direction	To SW
N/A	X Walk 1 Width (in)	N/A	N/A	X Walk 2 Width (in)	N/A
	X Walk 1 Slope (%)	2.4		X Walk 2 Slope (%)	4.0
	X Walk 1 X Slope (%)	3.2		X Walk 2 X Slope (%)	1.3

N/A	Ramp inside XWalk1?	N/A	N/A	Ramp inside XWalk2?	N/A
	Road Slope (%)	0.7	N/A	Clear Space?	N/A
	Road X Slope (%)	1.2	N/A	Clear Space to XWalk (in)	N/A
N/A	Any Obstructions?	N/A	N/A	Storm Grate/Utility Hazard?	N/A
	Obstruction Type			Storm Grate/Utility Type	
		N/A			N/A
		Yes		Surface Condition? (G/P)	Good

Remove & Replace Curb Ramp With Two New Directional Ramps or Equivalent.

Total Cost: \$ 3200.00
