# Access Compliance Report

## Public Rights-of-Way

### (Curb Ramps)

Intersection ID: 17738	Main Street: CORDER_DR	Cross Street: WINCHELSEA_DR	Location: NE
ADA ID: 107FE91519EC	Ramp Type: PerpDiag	Initial Pass/Fail: Fail	Overall Compliance: No
			Severity Score: 26.25

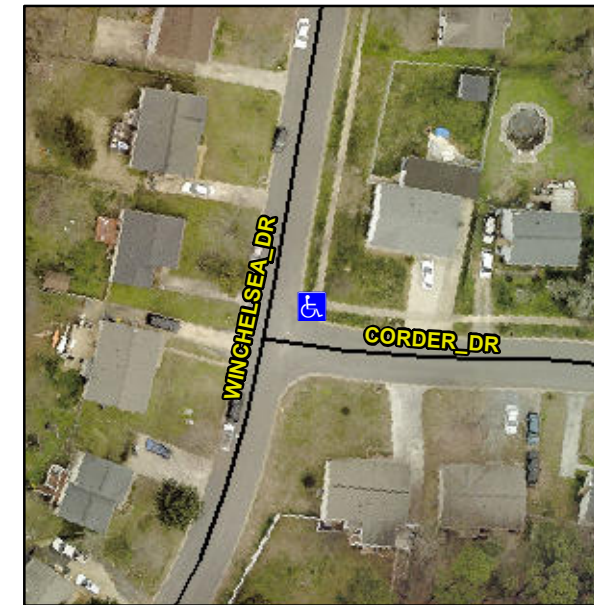
**Not Found, R304.2.2, R304.5.3**

Compliance	Description	Data	Compliance	Description	Data
N/A	Ramp Length (in)	46.0	No	Ramp Slope (%)	13.7
Yes	Ramp Width (in)	48.0	No	Ramp XSlope (%)	2.6
N/A	Flare Type LT	N/A	N/A	Flare Type RT	N/A
N/A	Flare Slope LT (%)	N/A	N/A	Flare Slope RT (%)	N/A
N/A	Flare Traversable LT?	N/A	N/A	Flare Traversable RT?	N/A
N/A	Landing Length (in)	N/A	N/A	DWS Provided?	N/A
N/A	Landing Width (in)	N/A	N/A	DWS Contrast?	N/A
N/A	Landing Slope (%)	N/A	N/A	DWS Length (in)	N/A
N/A	Landing X Slope (%)	N/A	N/A	DWS Full Width?	N/A
N/A	Landing Curb? (Y/N)	N/A	N/A	DWS Offset (in)	N/A
N/A	Shared Landing?	N/A			
N/A	Gutter Ponding?	N/A	N/A	Gutter Slope (%)	N/A
N/A	Gutter Lip Ht (in)	N/A	N/A	Gutter X Slope (%)	N/A
N/A	Painted X Walk1?	No	N/A	Painted X Walk2?	No
	X Walk 1 Direction	To SW		X Walk 2 Direction	To NW
N/A	X Walk 1 Width (in)	N/A	N/A	X Walk 2 Width (in)	N/A
	X Walk 1 Slope (%)	2.5		X Walk 2 Slope (%)	2.2
	X Walk 1 X Slope (%)	1.6		X Walk 2 X Slope (%)	2.8

N/A	Ramp inside XWalk1?	N/A	N/A	Ramp inside XWalk2?	N/A
	Road Slope (%)	2.7	N/A	Clear Space?	N/A
	Road X Slope (%)	0.9	N/A	Clear Space to XWalk (in)	N/A
N/A	Any Obstructions?	N/A	N/A	Storm Grate/Utility Hazard?	N/A
	Obstruction Type			Storm Grate/Utility Type	
		N/A			N/A
			Yes	Surface Condition? (G/P)	Good

**Remove & Replace Curb Ramp With Two New Directional Ramps or Equivalent.**

Total Cost: \$ 3200.00
