# Access Compliance Report

## Public Rights-of-Way

Intersection ID: 7091	Main Street: BROOKSHIRE_BV	Cross Street: HOVIS_RD	Location: S
ADA ID: 10887767CEE4	Ramp Type: Perp	Initial Pass/Fail: Fail	Overall Compliance: No
Severity Score: 21.25			
Codes/Mitigation Info/Possible Solution		Field Measurements/Component Compliance

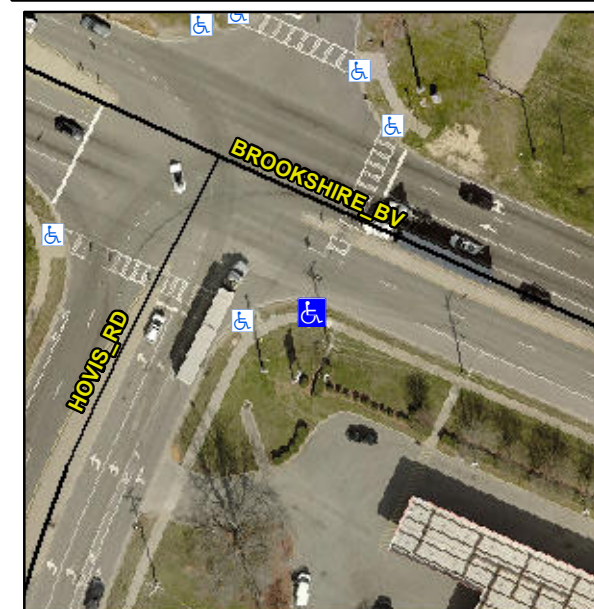
**Not Found, R304.5.1, R304.2.2**

Compliance	Description	Data	Compliance	Description	Data
N/A	Ramp Length (in)	53.0	No	Ramp Slope (%)	11.0
No	Ramp Width (in)	46.5	Yes	Ramp XSlope (%)	1.9
N/A	Flare Type LT	N/A	N/A	Flare Type RT	N/A
N/A	Flare Slope LT (%)	N/A	N/A	Flare Slope RT (%)	N/A
N/A	Flare Traversable LT?	N/A	N/A	Flare Traversable RT?	N/A
N/A	Landing Length (in)	N/A	N/A	DWS Provided?	N/A
N/A	Landing Width (in)	N/A	N/A	DWS Contrast?	N/A
N/A	Landing Slope (%)	N/A	N/A	DWS Length (in)	N/A
N/A	Landing X Slope (%)	N/A	N/A	DWS Full Width?	N/A
N/A	Landing Curb? (Y/N)	N/A	N/A	DWS Offset (in)	N/A
N/A	Shared Landing?	N/A			
N/A	Gutter Ponding?	N/A	N/A	Gutter Slope (%)	N/A
N/A	Gutter Lip Ht (in)	N/A	N/A	Gutter X Slope (%)	N/A
N/A	Painted X Walk1?	No	N/A	Painted X Walk2?	N/A
	X Walk 1 Direction	To NW		X Walk 2 Direction	N/A
N/A	X Walk 1 Width (in)	N/A	N/A	X Walk 2 Width (in)	N/A
	X Walk 1 Slope (%)	3.8		X Walk 2 Slope (%)	N/A
	X Walk 1 X Slope (%)	1.6		X Walk 2 X Slope (%)	N/A

N/A	Ramp inside XWalk1?	N/A	N/A	Ramp inside XWalk2?	N/A
	Road Slope (%)	N/A	N/A	Clear Space?	N/A
	Road X Slope (%)	N/A	N/A	Clear Space to XWalk (in)	N/A
N/A	Any Obstructions?	N/A	N/A	Storm Grate/Utility Hazard?	N/A
	Obstruction Type			Storm Grate/Utility Type	
		N/A			N/A
			Yes	Surface Condition? (G/P)	Good

**Remove & Replace Entire Ramp.**
