Access Compliance Report

Public Rights-of-Way

(Curb Ramps)

Intersection ID: N/A	Main Street: MAMMOTH_OAKS_DR	Cross Street: N/A	Location: S
ADA ID: 1089B2A543FC	Ramp Type: Para	Initial Pass/Fail: Fail	Overall Compliance: No
Codes/Mitigation Info/Possible Solution		Field Measurements/Component Compliance	
Severity Score: 26.25

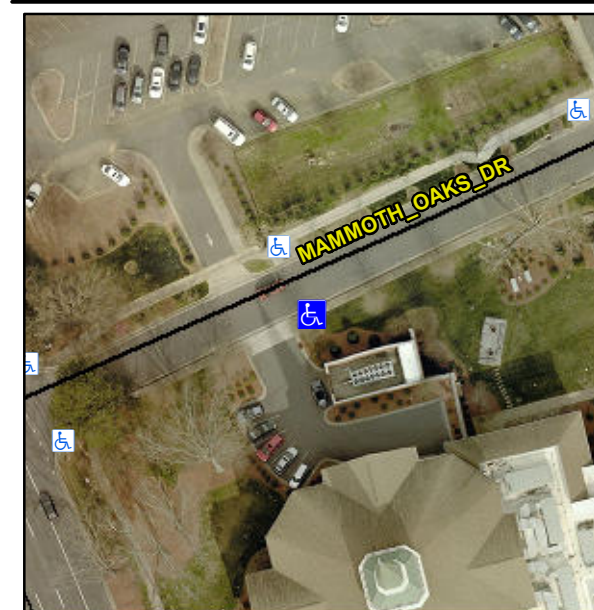
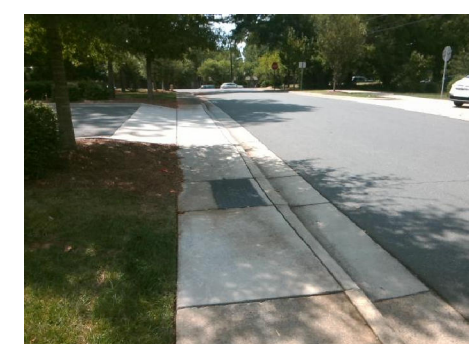
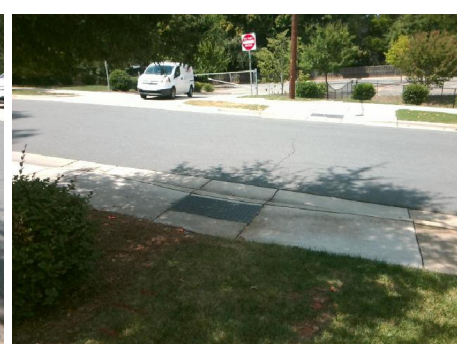
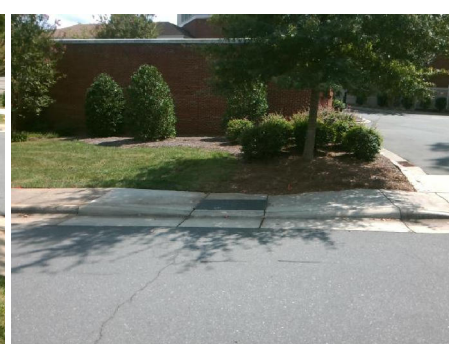
LT RP < 5%

R304.5.3, R304.3.2

Compliance	Description	Data	Compliance	Description	Data
N/A	Ramp Length LT (in)	77.0	N/A	Ramp Length RT (in)	79.0
Yes	Ramp Width LT (in)	48.0	Yes	Ramp Width RT (in)	48.0
Yes	Ramp Slope LT (%)	4.0	No	Ramp Slope RT (%)	15.2
No	Ramp XSlope LT (%)	2.6	Yes	Ramp XSlope RT (%)	0.5
N/A	Landing Length (in)	N/A	N/A	DWS Provided?	N/A
N/A	Landing Width (in)	N/A	N/A	DWS Contrast?	N/A
N/A	Landing Slope (%)	N/A	N/A	DWS Length (in)	N/A
N/A	Landing X Slope (%)	N/A	N/A	DWS Full Width?	N/A
N/A	Landing Curb? (Y/N)	N/A	N/A	DWS Offset (in)	N/A
N/A	Shared Landing?	N/A			
N/A	Gutter Ponding?	N/A	N/A	Gutter Slope (%)	N/A
N/A	Gutter Lip Ht (in)	N/A	N/A	Gutter X Slope (%)	N/A
N/A	Painted X Walk1?	No	N/A	Painted X Walk2?	N/A
	X Walk 1 Direction	To NW		X Walk 2 Direction	N/A
N/A	X Walk 1 Width (in)	N/A	N/A	X Walk 2 Width (in)	N/A
	X Walk 1 Slope (%)	3.8		X Walk 2 Slope (%)	N/A
	X Walk 1 X Slope (%)	9.1		X Walk 2 X Slope (%)	N/A
N/A	Ramp inside XWalk1?	N/A	N/A	Ramp inside XWalk2?	N/A

Road Slope (%)	N/A	N/A	Clear Space?	N/A
	Road X Slope (%)	N/A	N/A	Clear Space to XWalk (in)	N/A
N/A	Any Obstructions?	N/A	N/A	Storm Grate/Utility Hazard?	N/A
	Obstruction Type			Storm Grate/Utility Type	
		N/A			N/A
			Yes	Surface Condition? (G/P)	Good
			N/A	Curb Slope (%)	13.5

Possible Solutions:

Remove & Replace Entire Ramp.
